# JOINT INVESTIGATION REPORT

INCIDENT NO: 2671189 JIV report S/N: 0680

1. Fountain Incident Number: 2671189 2. Type of incident\* OIL SPILL  
3. Name of Location 4" SOKU WELL 23S FLOWLINE  
4. Name of nearest community EKINEAMA 2 BUSH BAR 5. State: RIVERS 6. LGA AKUKU-TORU  
7. Production Facility/Installation CRUDE OIL FLOWLINE  
8. Asset Owner/Hub THE SHELL PETROLEUM DEVELOPMENT COMPANY OF NIGERIA LIMITED / SWAMP EAST HUB

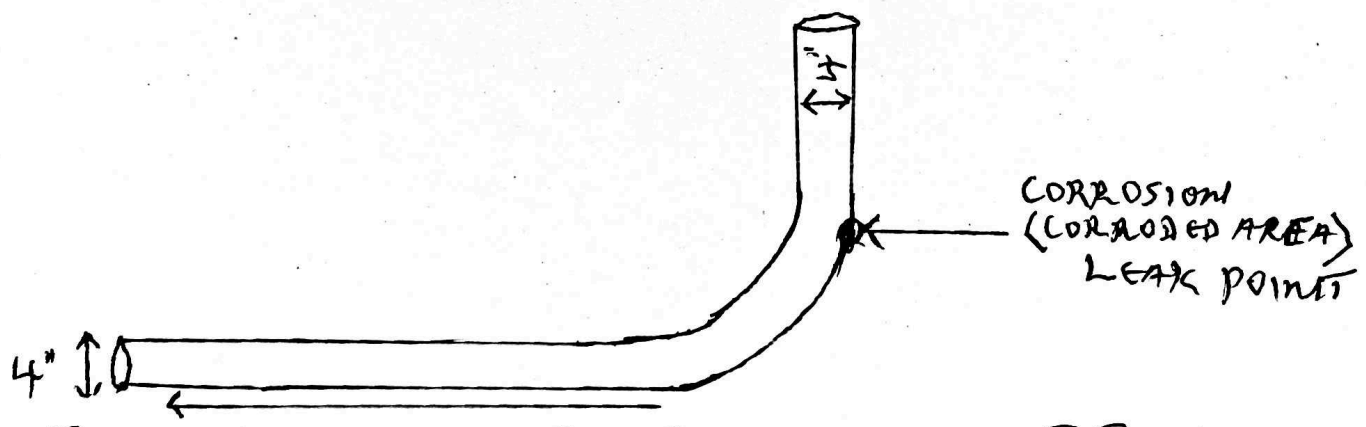
| <input checked="" type="checkbox"/> Others (specify) <u>CORROSION</u> | | |

SECTION OF 4" SOKU WELL 235 FLOWLINE AT EKINEAMA BUSH BAR SHOWING CORROSION (CORRODED AREA) AT 6 O'CLOCK POSITION.

REPAIR WORK ONGOING.
