# JOINT INVESTIGATION REPORT

INCIDENT NO: 2605522 JIV report S/N: 0473

1. Fountain Incident Number: 2605522 2. Type of incident\* OIL SPILL  
3. Name of Location 12" OGUTA-EGBEMA PIPELINE AT EZIORSU  
4. Name of nearest community EZIORSU 5. State: IMO 6. LGA OGUTA  
7. Production Facility/Installation CRUDE OIL PIPELINE  
8. Asset Owner/Hub THE SHELL PETROLEUM DEVELOPMENT COMPANY OF NIGERIA LIMITED (SPDC)/ PIPELINE

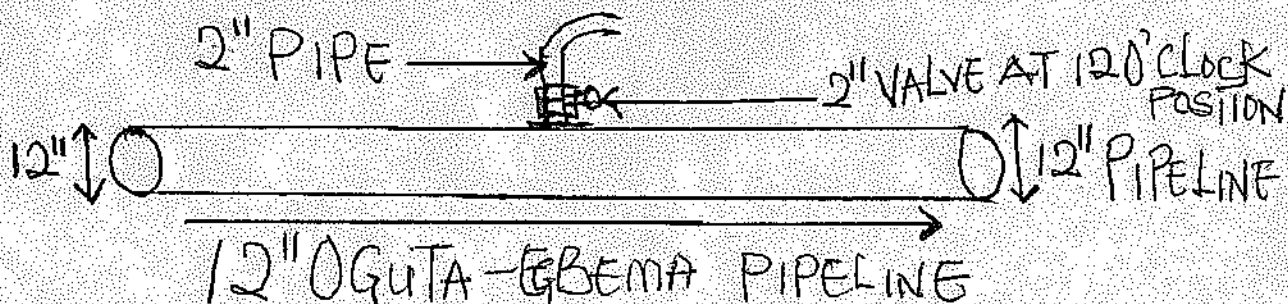
| <input checked="" type="checkbox"/> Crude oil theft (illegal bunkering) point, | <input type="checkbox"/> Saver-pit over flow | <input type="checkbox"/> Third party tampering with Clamp |

**E. GRAPHIC DESCRIPTION OF LEAK POINT** (while detailed description of the leak point should be contained in the leak report, overview sketch of the site should be added as appendix 1) A SECTION OF 12" OGUTA TO EGBEMA PIPELINE AT EZIORSU SHOWING 2" VALVE INSTALLED AT 12 O'CLOCK POSITION BY UNKNOWN PERSON(S).

CLAMPING AND OIL RECOVERY ON-GOING
