JOINT INVESTIGATION REPORT

INCIDENT NO: 2611196 JIV report S/N: 1030238

1. Fountain Incident Number: 2611196 2. Type of incident* OIL SPILL
3. Name of Location 2.8" NKPOKU - BOMU PIPELINE
4. Name of nearest community AKPAJO 5. State: RIVERS 6. LGA ELEME
7. Type of Production facility/Installation OIL PIPELINE
8. Asset owner/District THE SHELL PETROLEUM DEVELOPMENT COMPANY OF NIGERIA LTD (SPDC) / PIPELINE

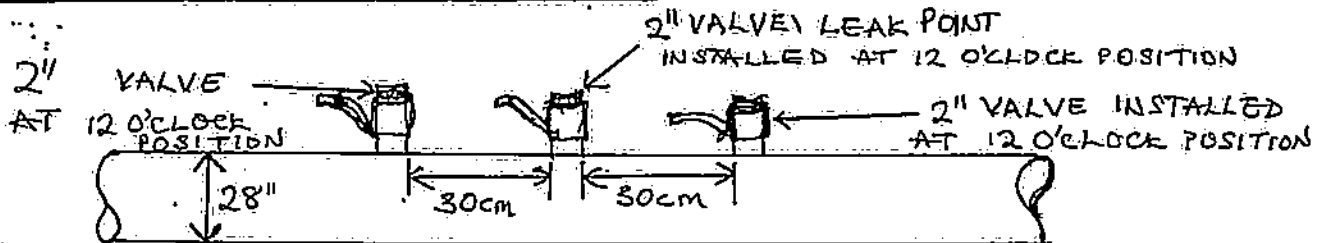
NKPOKU TO BOMU

E. GRAPHIC DESCRIPTION OF LEAK POINT (while detail report of the leak point should be contained in the leak report, overview sketch of the site should be added as an appendix 1). A SECTION OF 28" NKPOKU - BOMU PIPELINE AT AKPAJO SHOWING 3 Nos. 2" VALVE CRUDE THEFT POINT INSTALLED 30CM FROM EACH AT 12 O'CLOCK POSITIONS BY UNKNOWN PERSONS.

SPILL RECOVERY AND REPAIR BY CLAMPING
