# JOINT INVESTIGATION REPORT

INCIDENT NO: 2604155 JIV report S/N: 1030131

1. Fountain Incident Number: 2604155 2. Type of incident\* OIL SPILL  
3. Name of Location 4" ETELEBODU WELL I S FLOWLINE  
4. Name of nearest community OGBOLOMA 5. State: BAYELSA 6. LGA YENAGOA  
7. Type of Production facility/Installation OIL FLOWLINE  
8. Asset owner/District THE SHELL PETROLEUM DEVELOPMENT COMPANY OF NIGERIA LTD (SPDC) / CENTRAL HUB

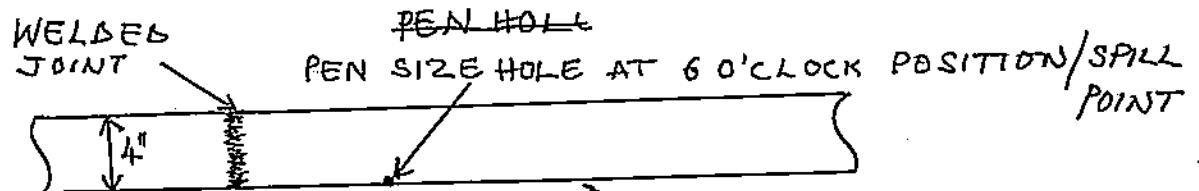
- Others (specify) ROUGH EDGED PEN SIZE HOLE

**E. GRAPHIC DESCRIPTION OF LEAK POINT** (while detail report of the leak point should be contained in the leak report, overview sketch of the site should be added as an appendix 1) A SECTION OF 4" ETELEBOU WELL IS FLOWLINE AT OGBOLOMA SHOWING A PEN SIZE HOLE SPILL POINT AT SIX O'CLOCK POSITION DUE TO EQUIPMENT FAILURE.
