JOINT INVESTIGATION REPORT

INCIDENT NO: 2609771 JIV report S/N: 0718

1. Fountain Incident Number: 2609771 2. Type of incident* CONDENSATE
3. Name of Location 6" NORTH BANK CENTRAL PROCESSING FACILITY CONDENSATE DELIVERY LINE
4. Name of nearest community OBOTOBO 5. State: DELTA 6. LGA BURUTU
7. Production Facility/Installation CONDENSATE DELIVERY LINE
8. Asset Owner/Hub THE SHELL PETROLEUM DEVELOPMENT COMPANY NIGERIA LIMITED / NORTH BANK NODE

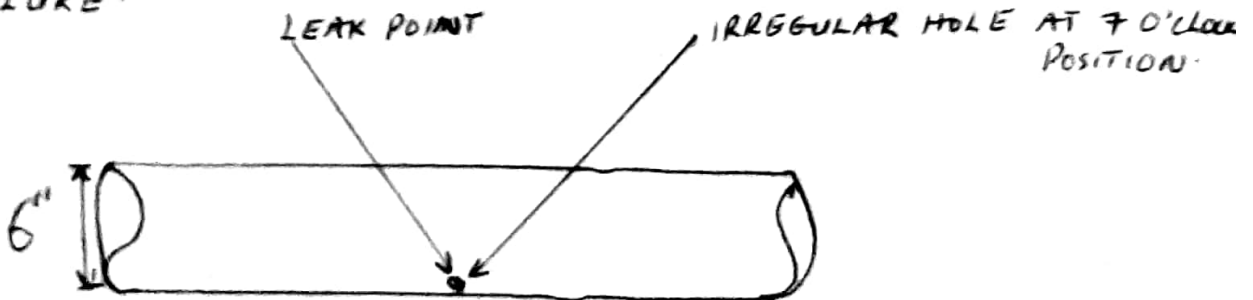
| <input checked="" type="checkbox"/> Others (specify) <u>IRREGULAR HOLE DUE TO EQUIPMENT FAILURE</u> | | |

A SECTION OF 6" NORTH BANK CENTRAL PROCESSING FACILITY CONDENSATE DELIVERY LINE AT OBDTOBO SHOWING IRREGULAR HOLE AT 7 O'CLOCK POSITION DUE TO EQUIPMENT FAILURE.
