JOINT INVESTIGATION REPORT

INCIDENT NO: 2616295 JIV report S/N: 0717

1. Fountain Incident Number: 2616295 2. Type of incident* OIL SPILL
3. Name of Location WELL HEAD 24 LIMA BEAN BOX
4. Name of nearest community BEINMO-DIOBD 5. State: BAYELSA 6. LGA EKEREMOR
7. Production Facility/Installation CRUDE OIL PIPELINE
8. Asset Owner/Hub THE SHELL PETROLEUM DEVELOPMENT COMPANY NIGERIA LIMITED / ASSET.

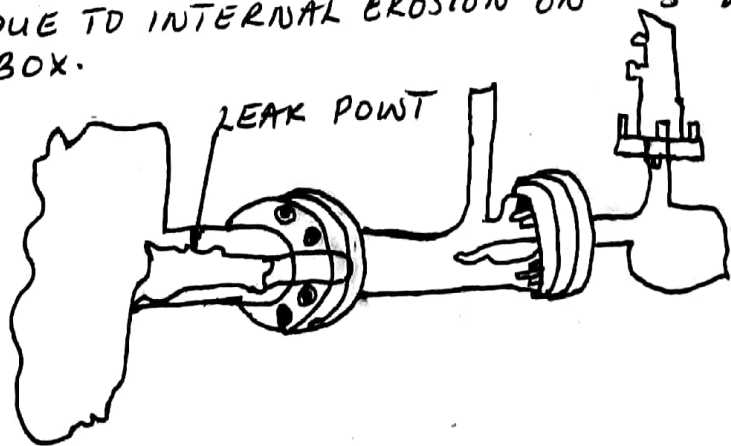
| <input checked="" type="checkbox"/> Tear (<u>BEAN BOX TEAR</u>

<u>DUE TO INTERNAL EROSION.</u>) | | |

A SECTION OF BENISEDE WELL 24 AT BENISEDE, SHOWING TEAR DUE TO INTERNAL EROSION ON 3" WELL HEAD 24 LIMA BEAN BOX.
