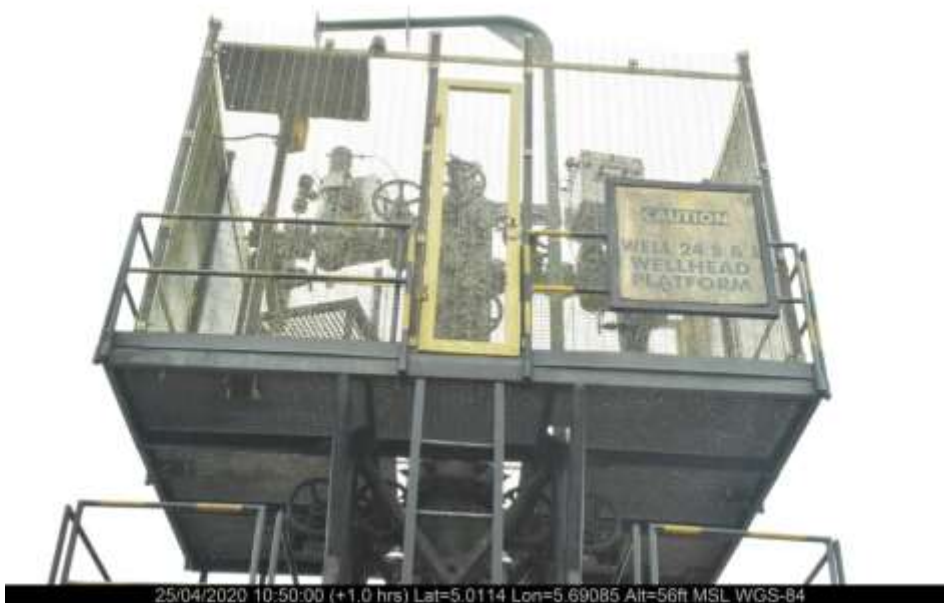
Overview: Part of spill impact on Well 24 Lima Bean Box at Ojobo. Picture was taken during Joint Investigation of 25th April 2020.

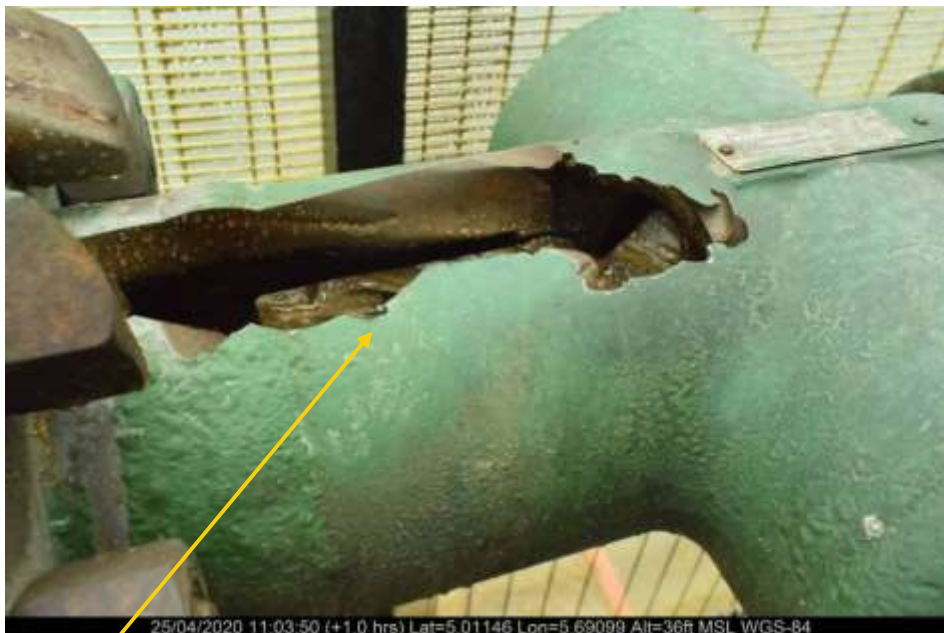
Close-up: Tear due to Internal erosion on 3" Well head on Well 24 Lima Bean Box at Ojobo. Picture was taken during Joint Investigation of 25th April 2020.

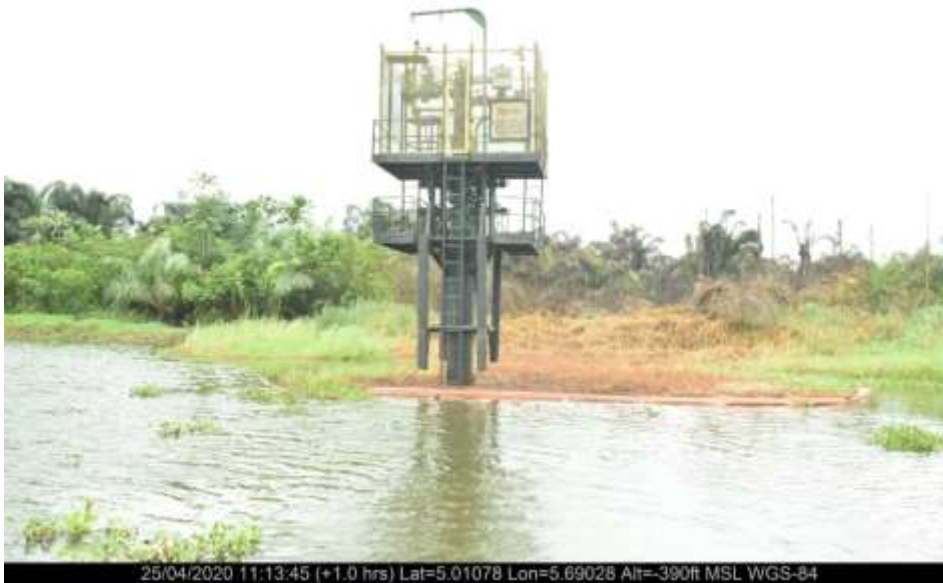
Overview: Part of spill impact on Well 24 Lima Bean Box at Ojobo. Picture was taken during Joint Investigation of 25th April 2020.

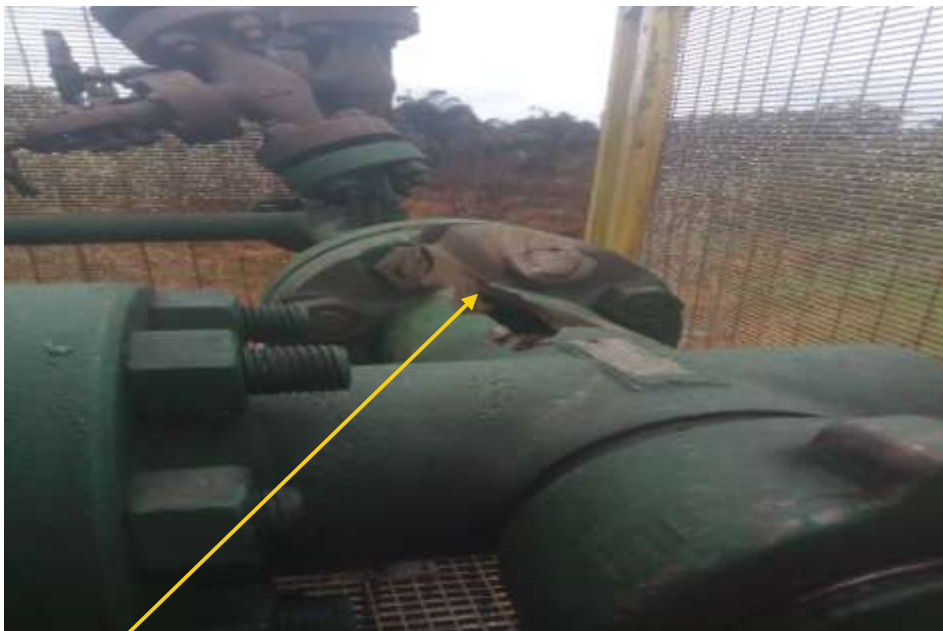
Close-up: Tear due to Internal erosion on 3" Well head on Well 24 Lima Bean Box at Ojobo. Picture was taken during Joint Investigation of 25th April 2020
