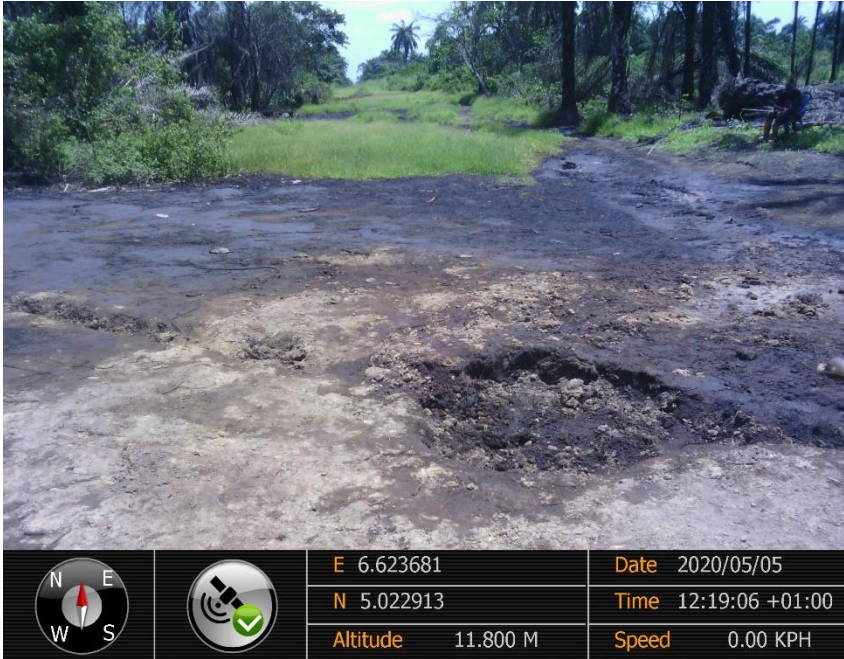
Overview: Part of spill impact on 14" Okordia Rumuekpe Pipeline at Edeoha. Picture was taken during Joint Investigation of 5th May 2020.

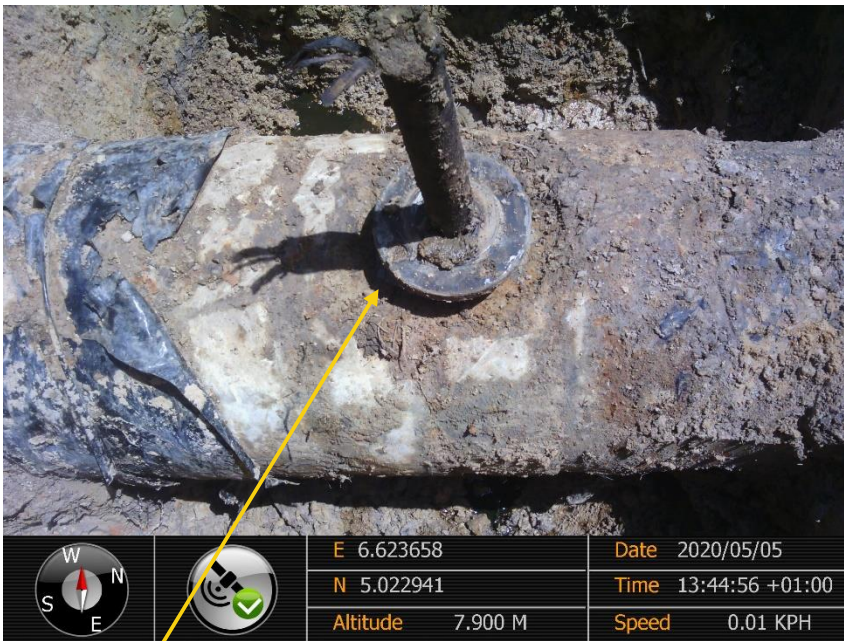
Close-up: 3" welded flange installed at 12 o'clock position on 14" Okordia Rumuekpe Pipeline at Edeoha. Picture was taken during Joint Investigation of 5th May 2020.
