# JOINT INVESTIGATION REPORT

INCIDENT NO: 2638020 JIV report S/N: 0491

1. Fountain Incident Number: 2638020 2. Type of incident: OIL SPILL  
3. Name of Location: 16" EGBEMA - ASSA PIPELINE  
4. Name of nearest community: ETEKURUS, State: IMD 6. LGA: OHASI/EGBEMA  
7. Production Facility/Installation: CRUDE OIL PIPELINE  
8. Asset Owner/Hub: THE SHELL PETROLEUM DEVELOPMENT COMPANY  
OF NIGERIA LIMITED / PIPELINE

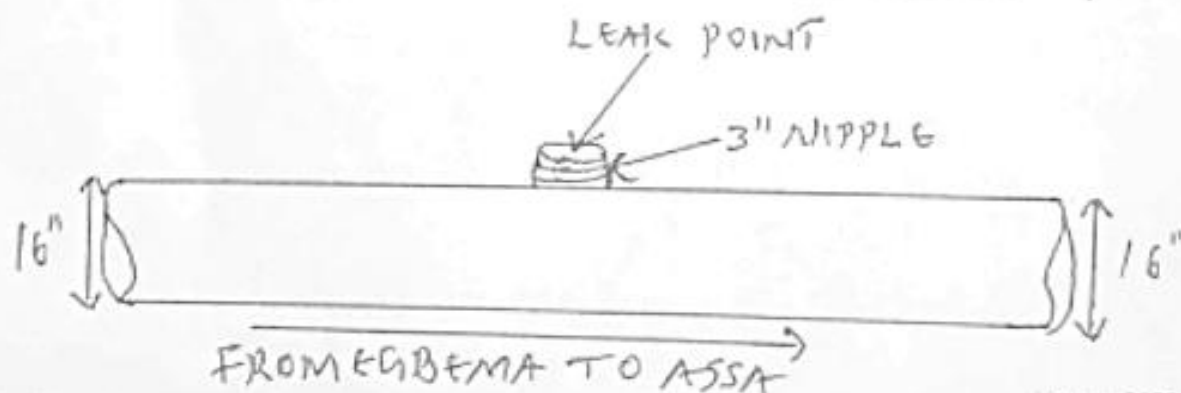
| <input checked="" type="checkbox"/> Crude oil theft (illegal bunkering) point, | <input type="checkbox"/> Saver-pit over flow | <input type="checkbox"/> Third party tampering with Clamp |

SECTION OF 16" EGBEMA-ASSA PIPELINE AT ETEKWUWA  
 SHOWING CRUDE OIL THEFT POINT INSTALLED AT 12 O'CLOCK  
 POSITION BY UNKNOWN PERSON(S).

CRUDE OIL RECOVERY AND REPAIR ACTIVITIES  
ARE ONGOING.
