JOINT INVESTIGATION REPORT

INCIDENT NO: 2638040 JIV report S/N: 0516

1. Fountain Incident Number: 2638040 2. Type of incident* OIL SPILL
3. Name of Location 8" NKALI - IMO RIVER 2 DELIVERY LINE
4. Name of nearest community ODAGWA 5. State: RIVERS 6. LGA ETCHE
7. Production Facility/Installation OIL DELIVERY LINE
8. Asset Owner/Hub THE SHELL PETROLEUM DEVELOPMENT COMPANY OF NIGERIA LTD (SPDC) / PIPELINE

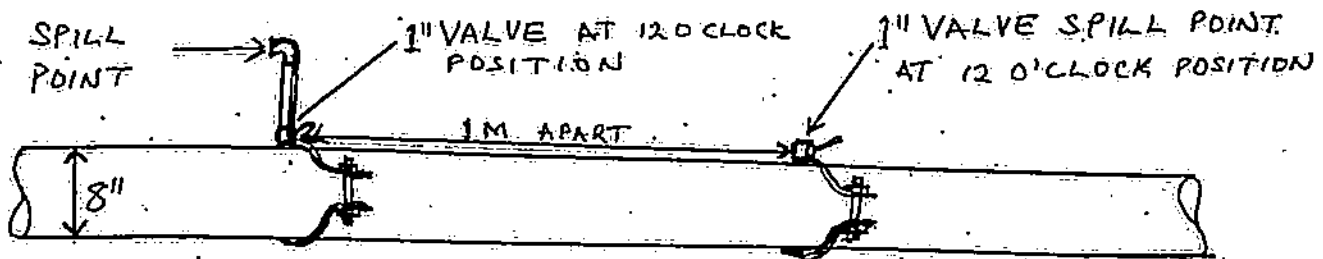
E. GRAPHIC DESCRIPTION OF LEAK POINT (while detailed description of the leak point should be contained in the leak report, overview sketch of the site should be added as appendix I) A SECTION OF 8" NKALI - IMD RIVER 2 DELIVERY LINE AT ODAQWA, SHOWING 2 NOS 1" VALVE CRUDE OIL THEFT POINTS INSTALLED ONE (1) METER APART AT 12 O'CLOCK POSITIONS BY UNKNOWN PERSONS

FROM NKALI TO IMD RIVER 2

REPAIR BY CLAMPING
