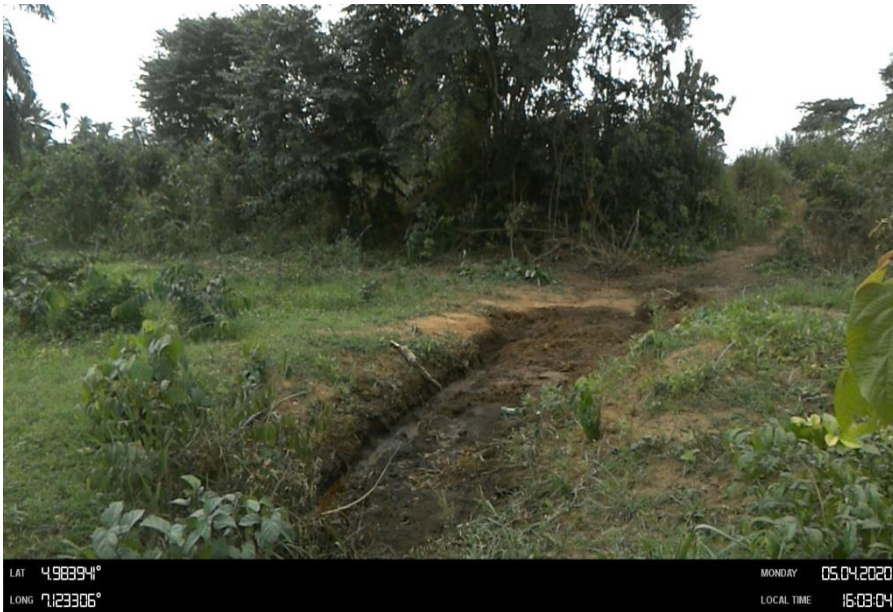
Overview: Part of spill impact on 8" Nkali – ImoRiver2 Pipeline at Odagwa. Picture was taken during Joint Investigation of 4th May 2020.

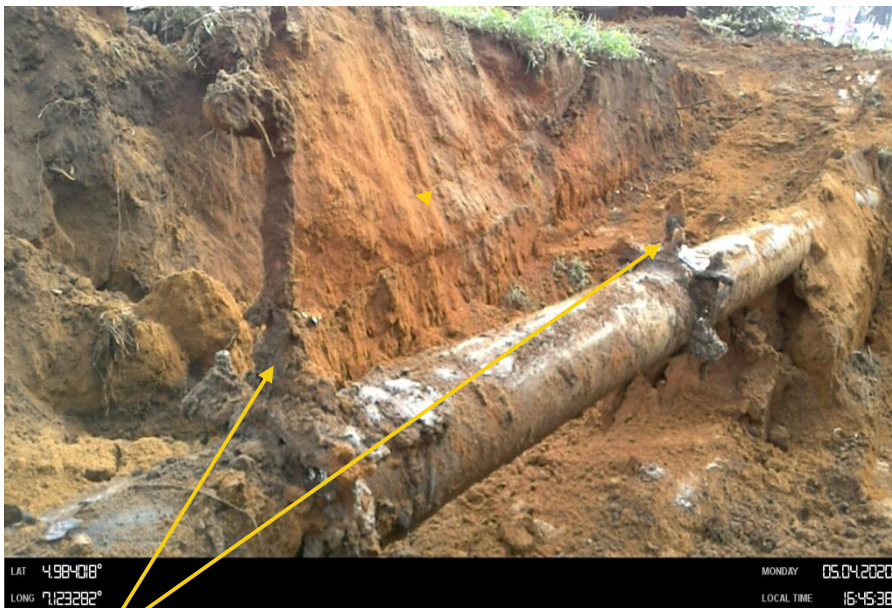
Close-up: 2 nos 1" valve crude oil theft points installed 1m apart at 12 o'clock position on 8" Nkali – ImoRiver2 Pipeline at Odagwa. Picture was taken during Joint Investigation of 4th May 2020.
