JOINT INVESTIGATION REPORT

INCIDENT NO: 2641163 JIV report S/N: 0532

1. Fountain Incident Number: 2641163 2. Type of incident* OIL SPILL
3" ADIBAWA WELL G T FLOW LINE FLANGE
3. Name of Location FLANGE LEAK ON 6 TANGD LINE AT ADIBAWA FLOW STATION
EDAGBERI
4. Name of nearest community BETTERLAND 5. State: RIVERS 6. LGA AHDADA WEST
ADIBAWA FLOW STATION / GBARAN KOLO - CREEK PRODUCTION UNIT
7. Production Facility/Installation THE SHELL PETROLEUM DEVELOPMENT COMPANY
8. Asset Owner/Hub THE SHELL PETROLEUM DEVELOPMENT COMPANY OF NIGERIA
LIMITED (SPDC) / GBARAN TO KOLO - CREEK HUB

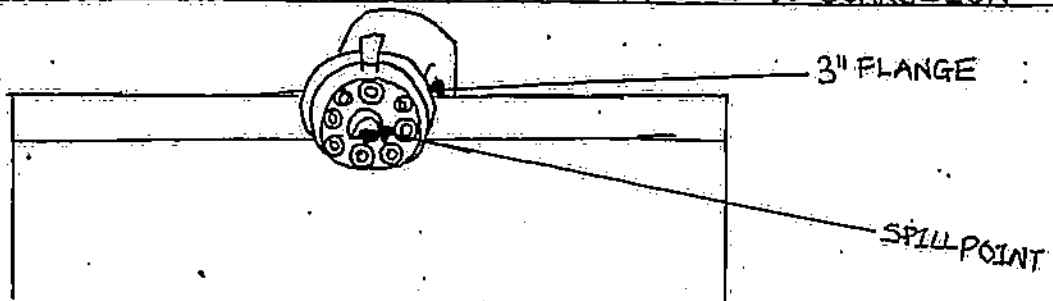
| <input checked="" type="checkbox"/> Others (specify) <u>CORROSION</u> | | |

A SECTION OF 3" ADIRAWA WELL 6 T FLOW LINE FLANGE AT EDAGBERI BETTERLAND SHOWING SPILL POINT DUE TO CORROSION
