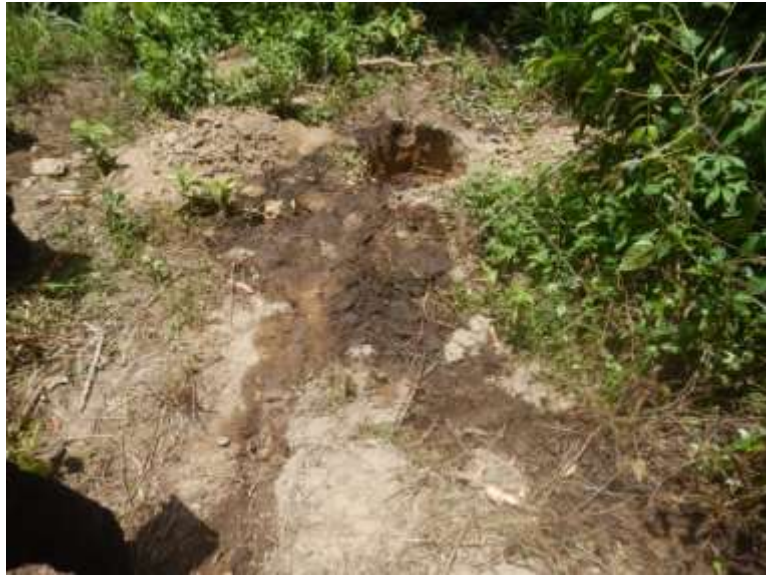
Overview: Part of spill impact on 4" ImoRiver Well 55s Flowline at Igiriukwu. Picture was taken during Joint Investigation 5th May 2020.

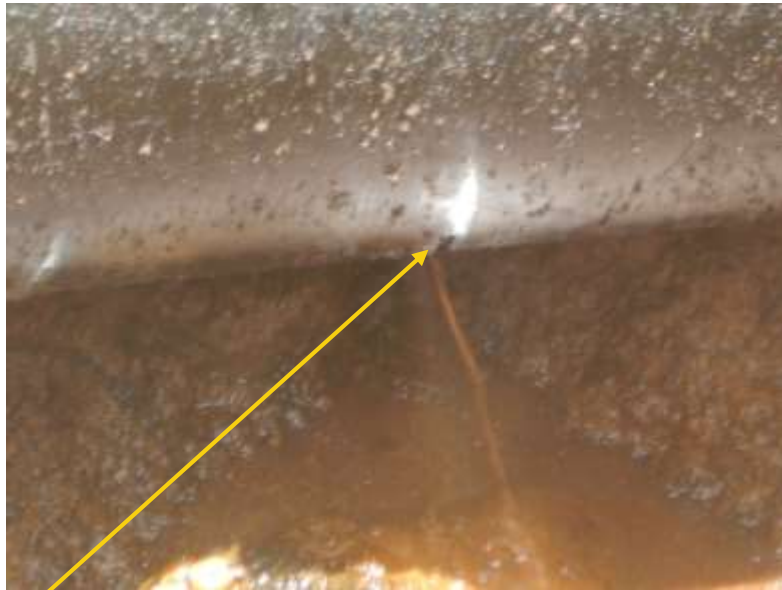
Close-up: Hacksaw cut at 6 o'clock position on 4" ImoRiver Well 55s Flowline at Igiriukwu. Picture was taken during Joint Investigation 5th May 2020.

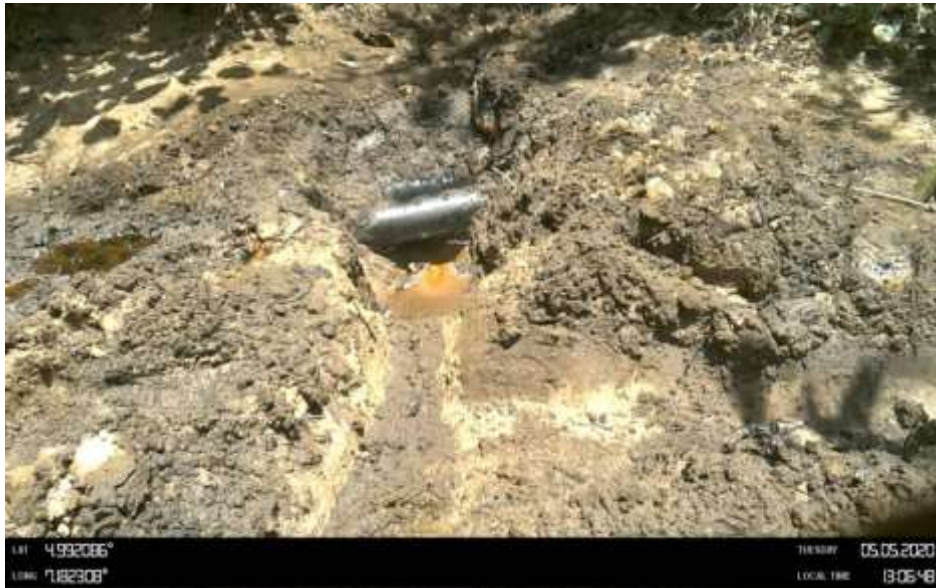
Overview: Part of spill impact on 4" ImoRiver Well 55s Flowline at Igiriukwu. Picture was taken during Joint Investigation 5th May 2020.

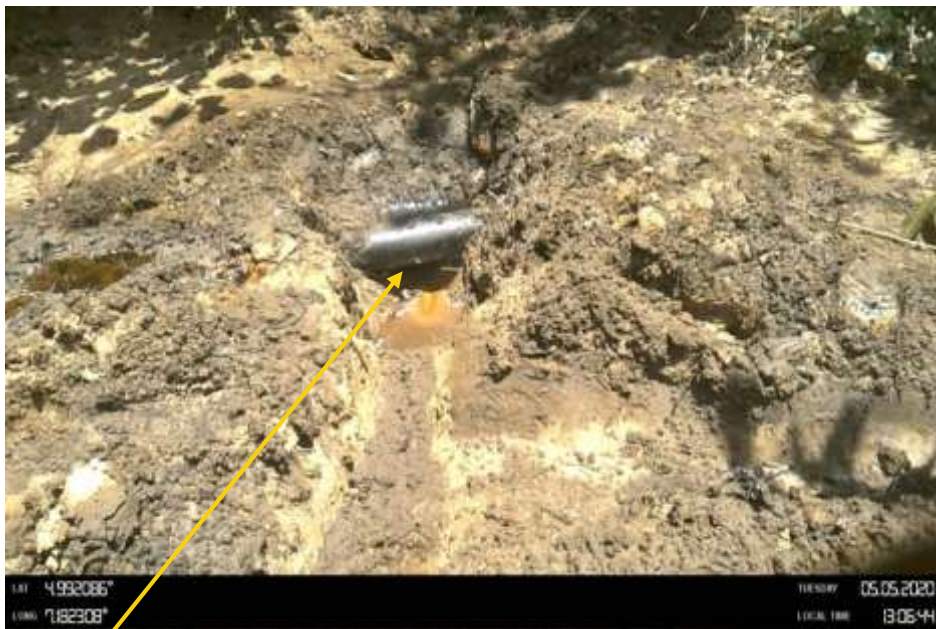
Close-up: Hacksaw cut at 6 o'clock position on 4" ImoRiver Well 55s Flowline at Igiriukwu. Picture was taken during Joint Investigation 5th May 2020.
