JOINT INVESTIGATION REPORT

INCIDENT NO: 2654233 JIV report S/N: 0538

1. Fountain Incident Number: 2654233 2. Type of incident* OIL SPILL
3. Name of Location 12" MORRIVER 2 - OGALE PIPELINE
4. Name of nearest community KOMKOM 5. State: RIVERS 6. LGA OYIGBO
7. Production Facility/Installation OIL PIPELINE
8. Asset Owner/Hub THE SHELL PETROLEUM DEVELOPMENT COMPANY
OF NIGERIA LIMITED / PIPELINE

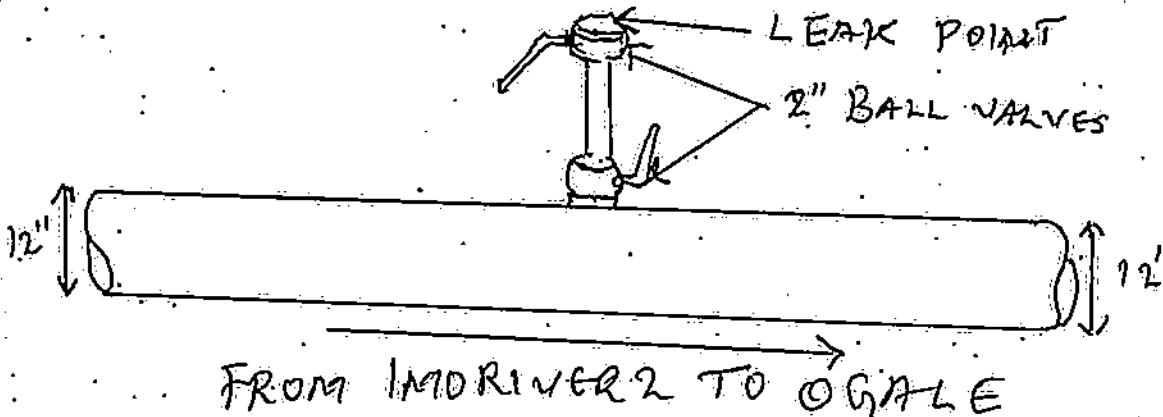
| <input checked="" type="checkbox"/> Crude oil theft (illegal bunkering) point, | <input type="checkbox"/> Saver-pit over flow | <input type="checkbox"/> Third party tampering with Clamp |

- Third party interference (Sabotage ; crude theft ; Line theft ; Accidental 3rd party damage
 Operational Others (including Mystery spills) _____

SECTION OF 12" IMORIVER 2 = OGALE PIPELINE AT KAMKOM SHOWING CRUDE OIL THEFT POINT INSTALLED AT 12 O'CLOCK POSITION!

OIL SPILL RECOVERY AND REPAIR WORK ARE ONGOING.

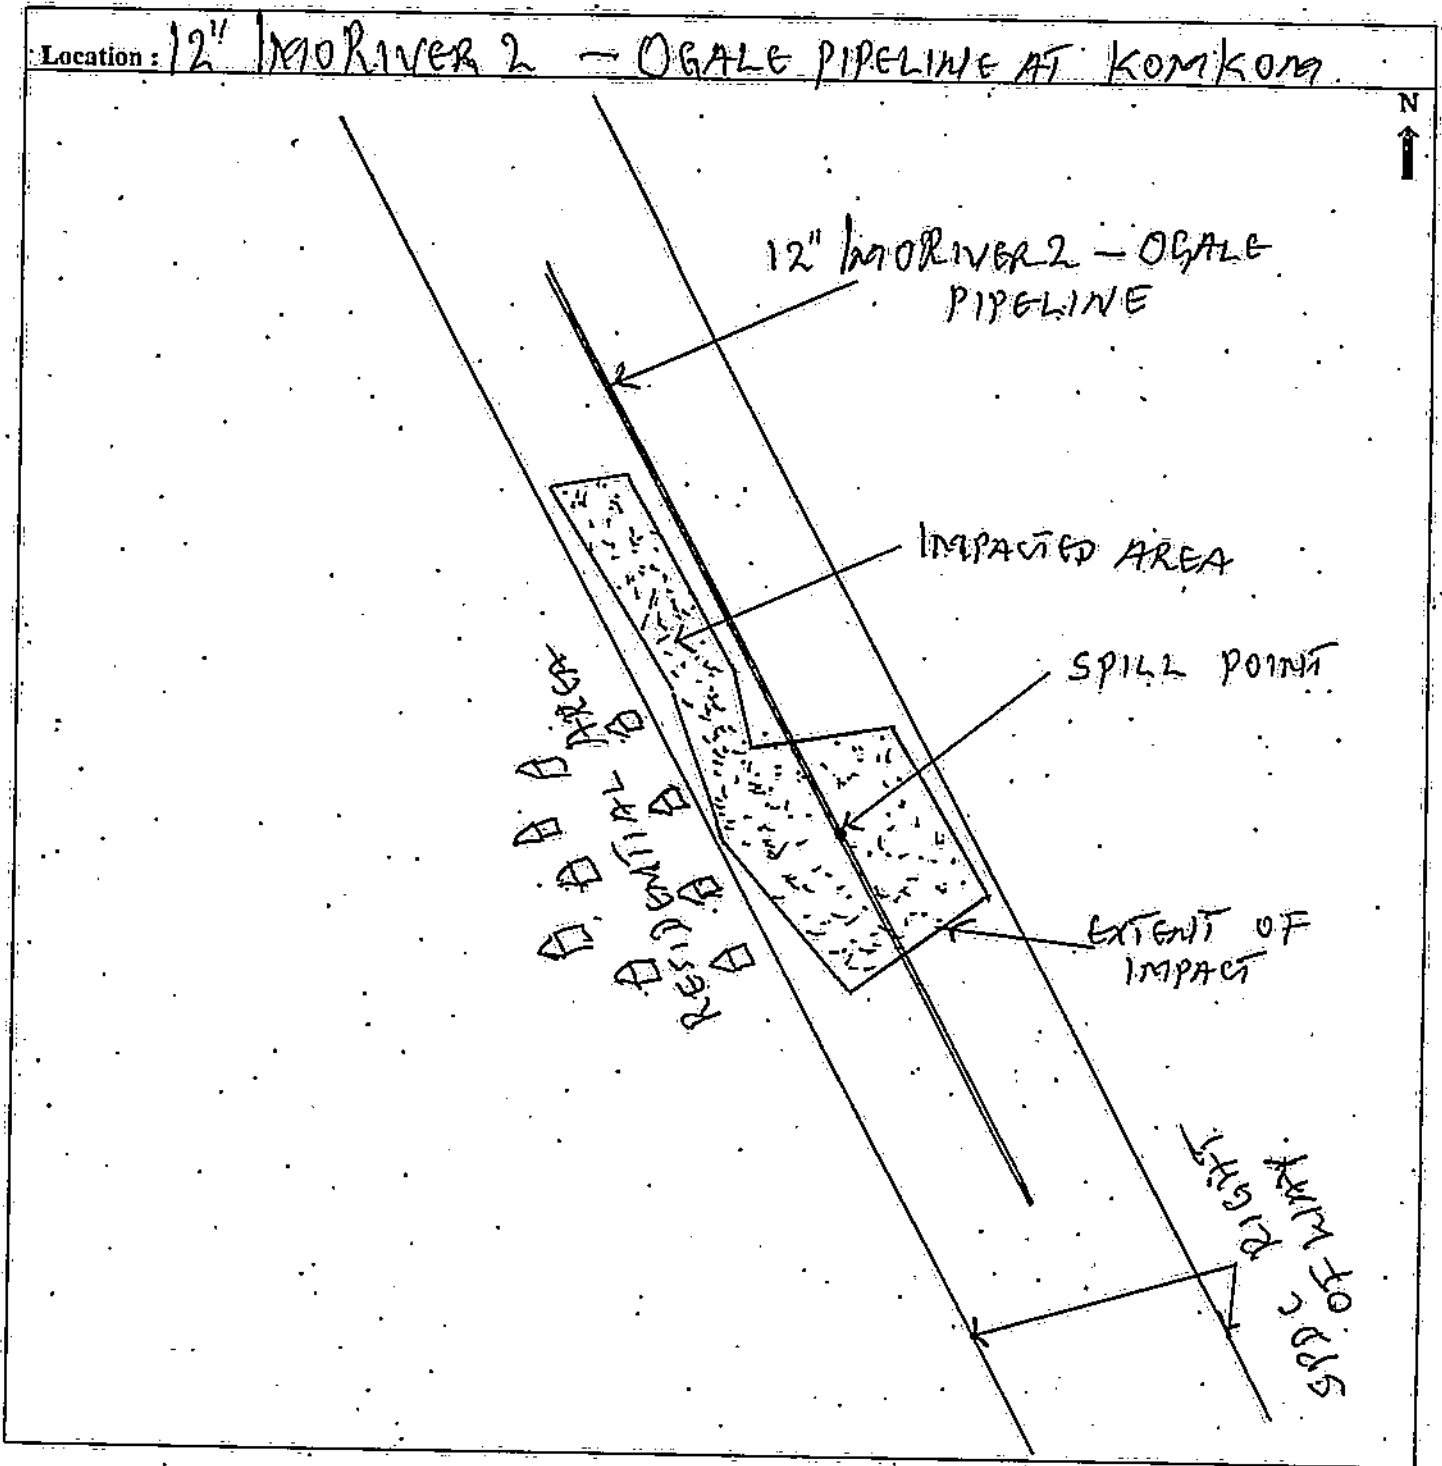
f. Appendix I: Overview sketch of the site

BURNT AREA AND SAND BAGS WERE OBSERVED.
