JOINT INVESTIGATION REPORT

INCIDENT NO: 2651874 JIV report S/N:

1. Fountain Incident Number: 2651874 2. Type of incident* OIL SPILL
3. Name of Location 4" KANBO WELL S LIMA FLOW LINE
4. Name of nearest community TUNU 5. State: BAYELSA 6. LGA EKEREMO
7. Production Facility/Installation CRUDE OIL FLOW LINE
8. Asset Owner/Hub THE SHELL PETROLEUM DEVELOPMENT COMPANY NIGERIA LIMITED / TUNU NODE

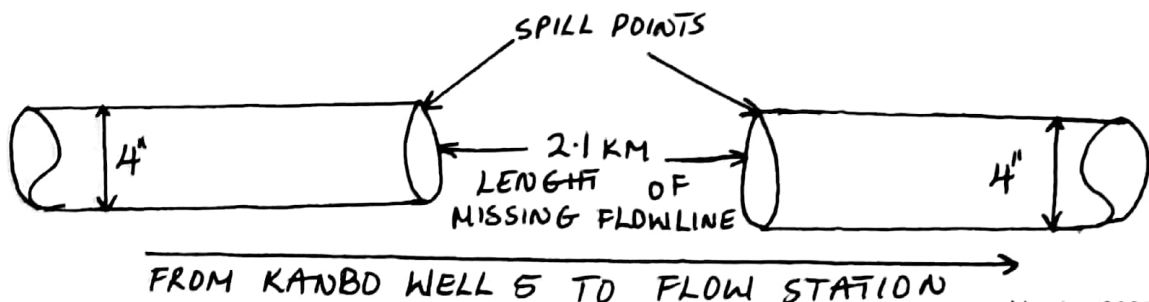
E. GRAPHIC DESCRIPTION OF LEAK POINT (while detailed description of the leak point should be contained in the leak report, overview sketch of the site should be added as appendix 1)

A SECTION OF 4" KANBO WELL 5 LIMA FLOWLINE AT TUNU SHOWING 2.1 KM LENGTH OF MISSING FLOWLINE, CUT AND CARRIED AWAY BY UNKNOWN PERSON(S).
