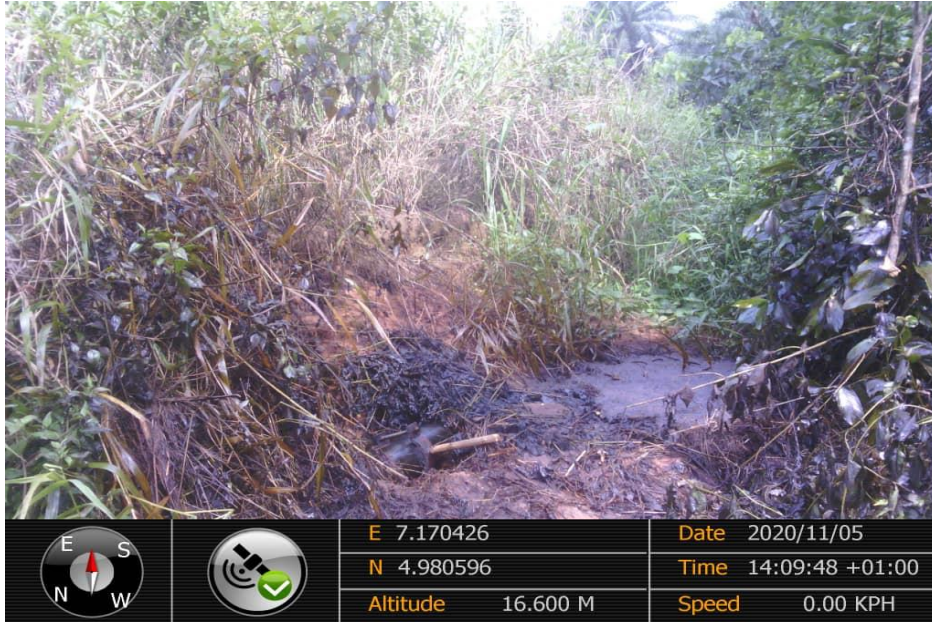
Overview: Part of spill impact on 6inch Imoriver2- Imoriver1 bulkline at Odagwa . Picture was taken during Joint Investigation on 5th November 2020.

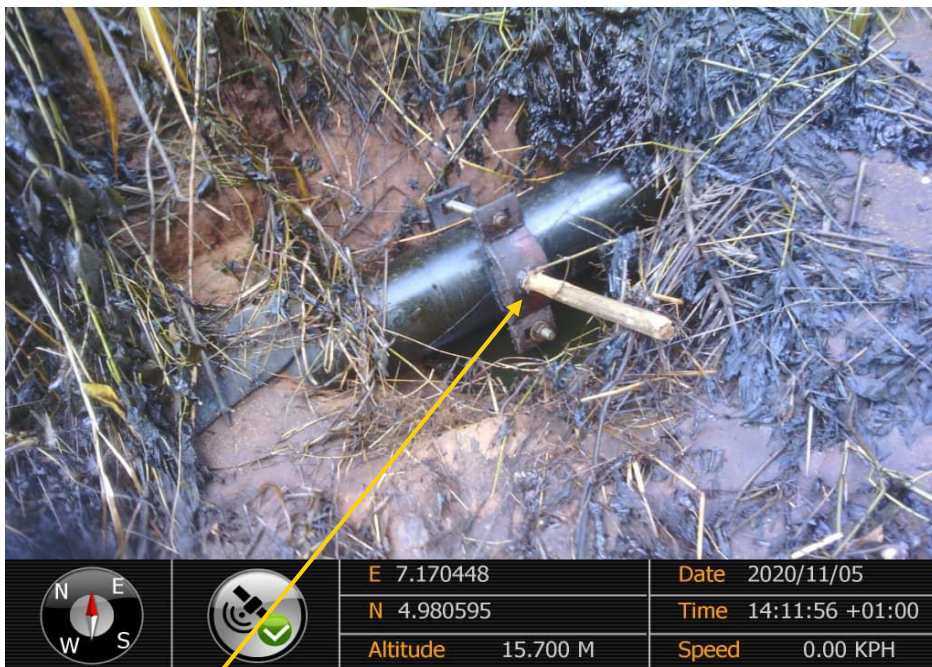
Close-up: Plugged drilled hole through a locally fabricated clamp at 2 o'clock position on 6'' Imoriver2 Imoriver1 bulkline at Odagwa . Picture was taken during Joint Investigation on 5th November 2020.
