# JOINT INVESTIGATION REPORT

INCIDENT NO: 2775976 JIV report S/N: 0605

1. Fountain Incident Number: 2775976 2. Type of incident\* OIL SPILL  
3. Name of Location 8" AGBADA 2 - NKYOKU PIPELINE  
4. Name of nearest community RUKPOKWU 5. State: RIVERS 6. LGA OBIO AKPOR  
7. Production Facility/Installation CRUDE OIL PIPELINE  
8. Asset Owner/Hub THE SHELL PETROLEUM DEVELOPMENT COMPANY  
OF NIGERIA LIMITED / PIPELINE

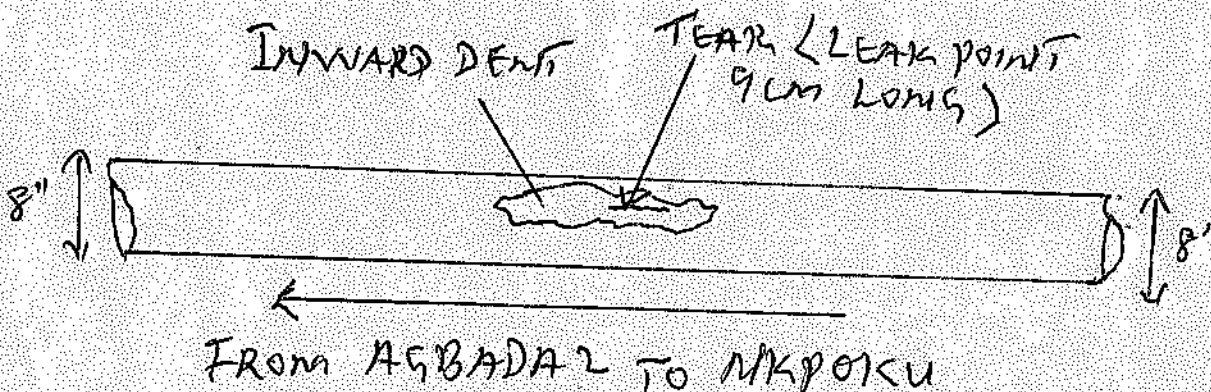
Others (specify) EQUIPMENT FAILURE

SECTION OF 8" AGBADA 2 - MKPOKU PIPELINE AT RUKPOKUNU  
SHOWING POSITION OF EQUIPMENT FAILURE AT 9 O'CLOCK.

RECOVERY AND REPAIR ACTIVITIES ARE ONGOING.

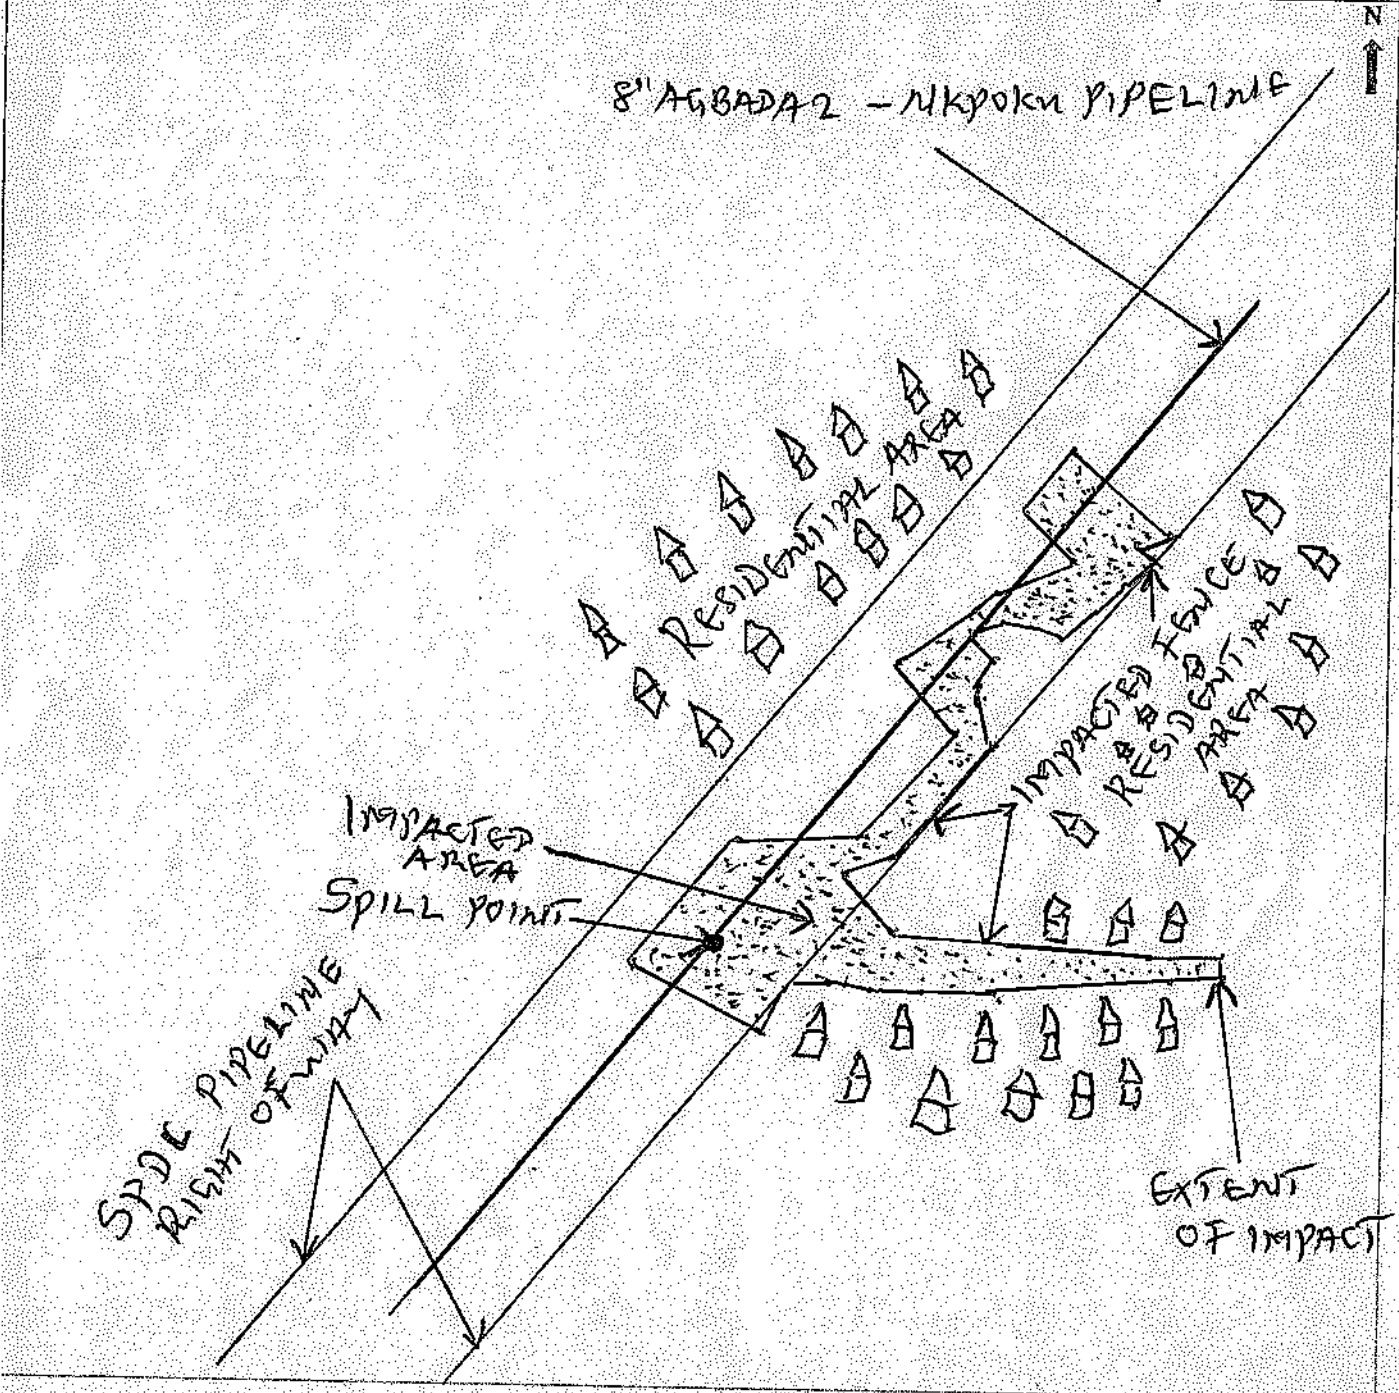
f. Appendix 1: Overview sketch of the site

Location: 8" AGBADA 2 - NKPOKU PIPELINE AT RUKPOKWI
