# JOINT INVESTIGATION REPORT

INCIDENT NO: 2774574 JIV report S/N: 0607

1. Fountain Incident Number: 2774574 2. Type of incident\* OIL SPILL  
3. Name of Location SOKU WELL 14L  
4. Name of nearest community SOKU 5. State: RIVERS 6. LGA AKUKUTORU  
7. Production Facility/Installation WELL HEAD  
8. Asset Owner/Hub THE SHELL PETROLEUM DEVELOPMENT COMPANY OF NIGERIA LIMITED (SPDC) / CENTRAL EAST HUB

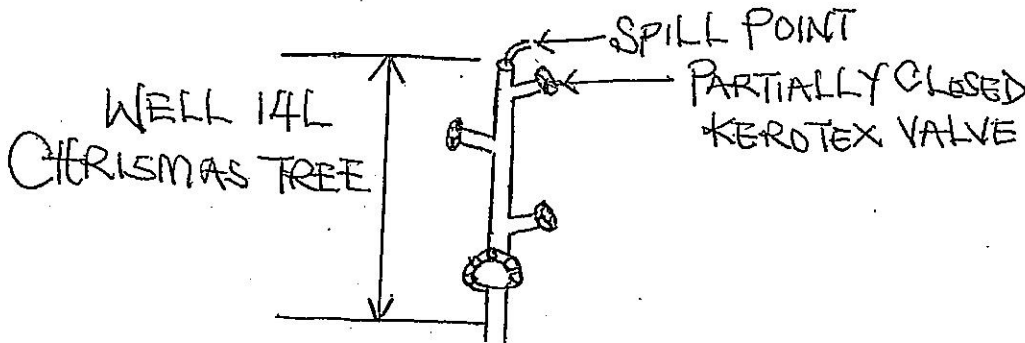
Tear ( )  
 Others (specify) PARTIALLY CLOSED KEROTEX VALVE

**E. GRAPHIC DESCRIPTION OF LEAK POINT** *(while detailed description of the leak point should be contained in the leak report, overview sketch of the site should be added as appendix 1)* A SECTION OF SOKU WELL 14L WELL HEAD AT SOKU SHOWING A PARTIALLY CLOSED KEROTEX VALVE AFTER WELL HEAD MAINTENANCE
