# JOINT INVESTIGATION REPORT

INCIDENT NO: 2783089 JIV report S/N:

1. Fountain Incident Number: 2783089 2. Type of incident\* OIL SPILL/FIRE  
3. Name of Location 18" ASSA-RUMU EKPE PIPELINE  
4. Name of nearest community AKPABU/ELELE ALIMINI RIVERS 5. State: RIVERS 6. LGA EMO HUA  
7. Production Facility/Installation OIL PIPELINE  
8. Asset Owner/Hub THE SHELL PETROLEUM DEVELOPMENT COMPANY OF NIGERIA LIMITED (SPDC) / PIPELINE

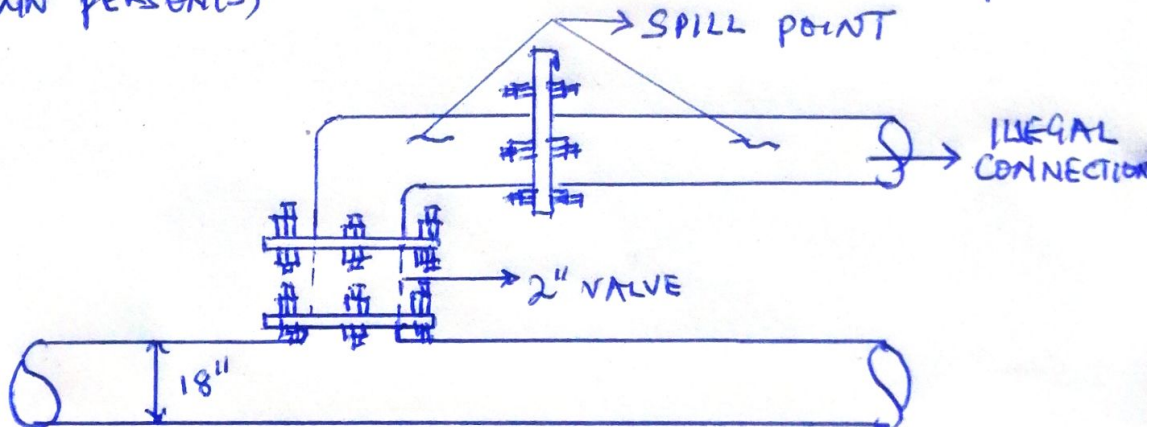
| <input checked="" type="checkbox"/> Crude oil theft (illegal bunkering) point, | <input type="checkbox"/> Saver-pit over flow | <input type="checkbox"/> Third party tampering with Clamp |

ASSA-RUMUEKPE PIPELINE AT AKPABU/ELELE ALIMINI SHOWING 2" VALVE ILLEGAL CONNECTION INSTALLED AT 12 O'CLOCK POSITION BY UNKNOWN PERSON(S)

SPILL RECOVERY / REPAIR BY CLAMPING
