JOINT INVESTIGATION REPORT

INCIDENT NO: 2779835 JIV report S/N: 0691

1. Fountain Incident Number: 2779835 2. Type of incident* OIL SPILL
3. Name of Location 20" TRANS ESCRAVOS PIPELINE
4. Name of nearest community OGIDIGBEN 5. State: DELTA 6. LGA WARRI SOUTH-WEST
7. Production Facility/Installation OIL PIPELINE
8. Asset Owner/Hub THE SHELL PETROLEUM DEVELOPMENT COMPANY OF NIGERIA LIMITED (SPDC/PIPELINE)

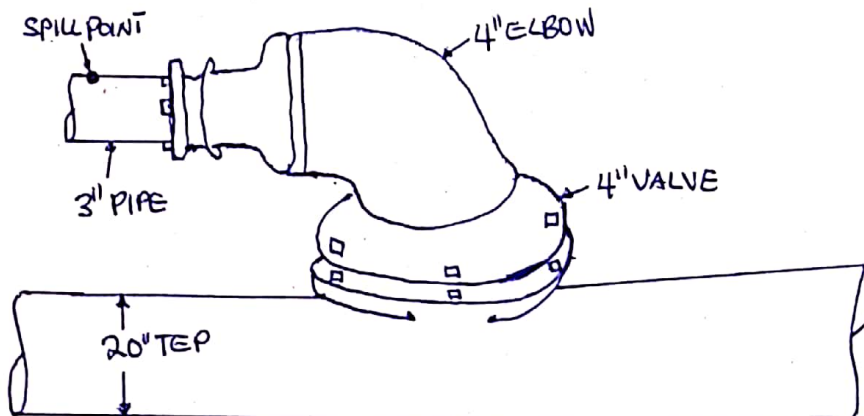
Additional observations around the spill point: THE JOINT INVESTIGATION TEAM OBSERVED 4" ILLEGAL HOT TAP VALVE WITH 4" ELBOW REDUCED TO 3" PIPE (LEAKING) CONNECTED ON THE 20" TRANS ESCRAVOS PIPELINE

| <input checked="" type="checkbox"/> Crude oil theft (illegal bunkering) point, | <input type="checkbox"/> Saver-pit over flow | <input type="checkbox"/> Third party tampering with Clamp |

E. GRAPHIC DESCRIPTION OF LEAK POINT (while detailed description of the leak point should be contained in the leak report, overview sketch of the site should be added as appendix 1) A SECTION OF 20" TRANS ESCRANS PIPELINE AT OGIDIGBEN SHOWING 4" VALVE WITH 4" ELBOW REDUCED TO 3" PIPE INSTALLED AT 12 O'CLOCK POSITION BY UNKNOWN PERSONS

SPILL RECOVERY / BLINDED WITH BLIND FLANGE
