JOINT INVESTIGATION REPORT

INCIDENT NO: 2785822 JIV report S/N:

1. Fountain Incident Number: 2785822 2. Type of incident* OIL SPILL
3. Name of Location 14" OKORDIA-RUMUEKPE TRUNKLINE AT EDEOHA
4. Name of nearest community EDEOHA 5. State: RIVERS 6. LGA AHOADA EAST
7. Production Facility/Installation OIL PIPELINE
8. Asset Owner/Hub THE SHELL PETROLEUM DEVELOPMENT COMPANY OF NIGERIA

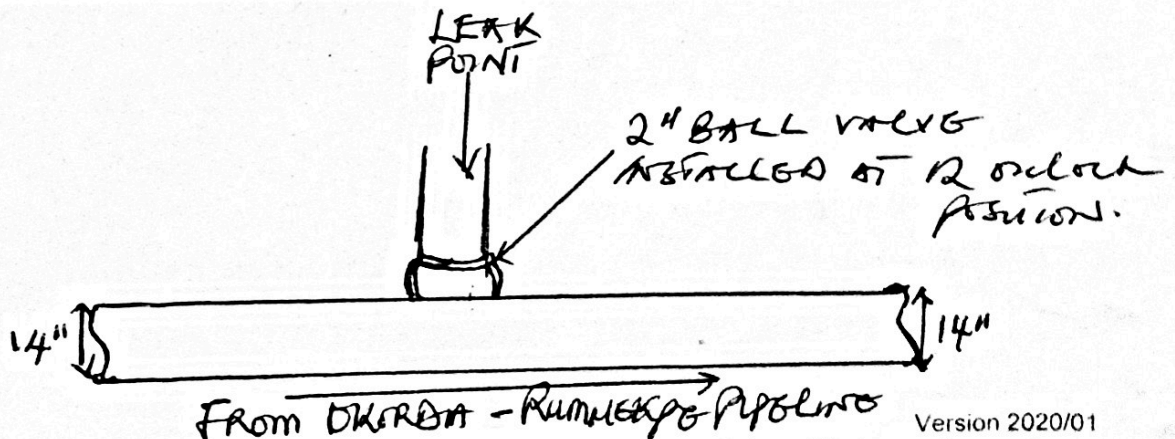
E. GRAPHIC DESCRIPTION OF LEAK POINT (while detailed description of the leak point should be contained in the leak report, overview sketch of the site should be added as appendix 1) A SECTION OF 14" OKORDIA-RUMUKPE PIPELINE AT EDEOMA SHOWING A 2" BALL VALVE INSTALLED AT 12 O'CLOCK POSITION BY UNKNOWN PERSONS.
