JOINT INVESTIGATION REPORT

INCIDENT NO: 2780621 JIV report S/N: 0615

1. Fountain Incident Number: 2780621 2. Type of incident* OIL SPILL
3. Name of Location 20" Kolo Creek-RumuKpe Trunkline at Owerewere
4. Name of nearest community Owerewere 5. State: RIVERS 6. LGA ABUA/ODUAL
7. Production Facility/Installation OIL PIPELINE
8. Asset Owner/Hub THE SHELL PETROLEUM DEVELOPMENT COMPANY OF NIGERIA

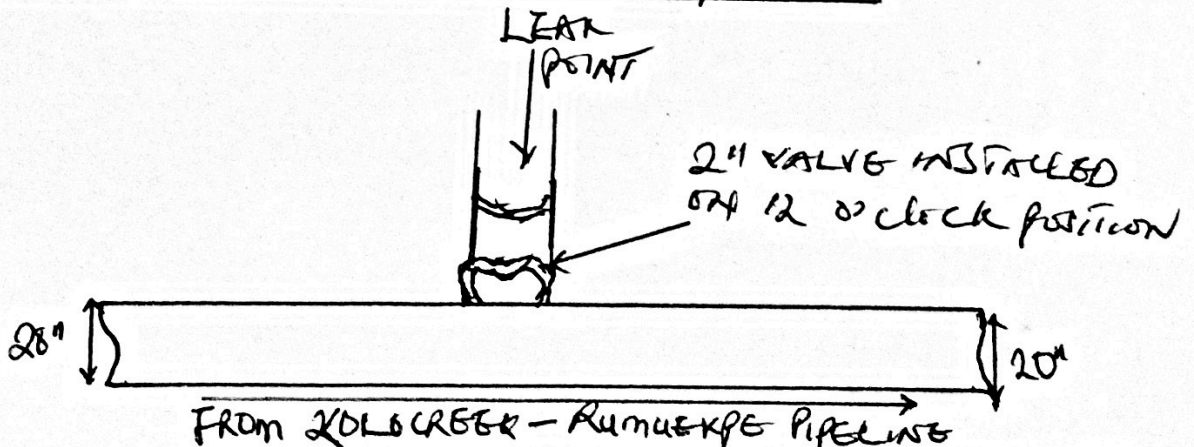
E. GRAPHIC DESCRIPTION OF LEAK POINT (while detailed description of the leak point should be contained in the leak report, overview sketch of the site should be added as appendix 1)

RUMUCKE PIPELINE AT ONEREKERE STATIONING A 2" VALVE ON 12 O'CLOCK POSITION BY UNKNOWN PERSONS.
