# JOINT INVESTIGATION REPORT

INCIDENT NO: 2781793 JIV report S/N: 0620

1. Fountain Incident Number: 2781793 2. Type of incident\* OIL SPILL  
3. Name of Location 12" IMOR I - OGALE PIPELINE  
4. Name of nearest community OKOJIA 5. State: ABIA 6. LGA UKWA WEST  
7. Production Facility/Installation PIPELINE  
8. Asset Owner/Hub THE SHELL PETROLEUM DEVELOPMENT COMPANY OF NIGERIA LIMITED (SPDC)/PIPELINE

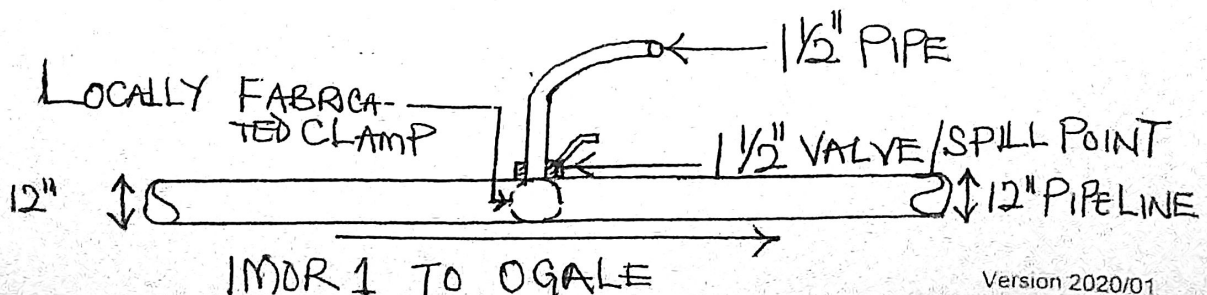
| <input checked="" type="checkbox"/> Crude oil theft (illegal bunkering) point, | <input type="checkbox"/> Saver-pit over flow | <input type="checkbox"/> Third party tampering with Clamp |

**E. GRAPHIC DESCRIPTION OF LEAK POINT** (while detailed description of the leak point should be contained in the leak report, overview sketch of the site should be added as appendix 1) A SECTION OF 12" IMOR 1 - OGALE PIPE LINE AT OKOTIA SHOWING A LOCAL FABRICATED CLAMP FITTED WITH 1/2" VALVE INSTALLED AT 12 O'CLOCK POSITION BY UNKNOWN PERSON(S).

CLAMPING ONGOING
