# JOINT INVESTIGATION REPORT

INCIDENT NO: 2789003 JIV report S/N: 0699

1. Fountain Incident Number: 2789003 2. Type of incident\* OIL SPILL  
3. Name of Location 6" SEIBUD WELL 3 & 4 BULKLINE  
4. Name of nearest community AGBIDIAMA State: BAYELSA 6. LGA EKEREMO  
7. Production Facility/Installation BULK LINE  
8. Asset Owner/Hub THE SHELL PETROLEUM DEVELOPMENT COMPANY NIGERIA LIMITED / SWAMP WEST

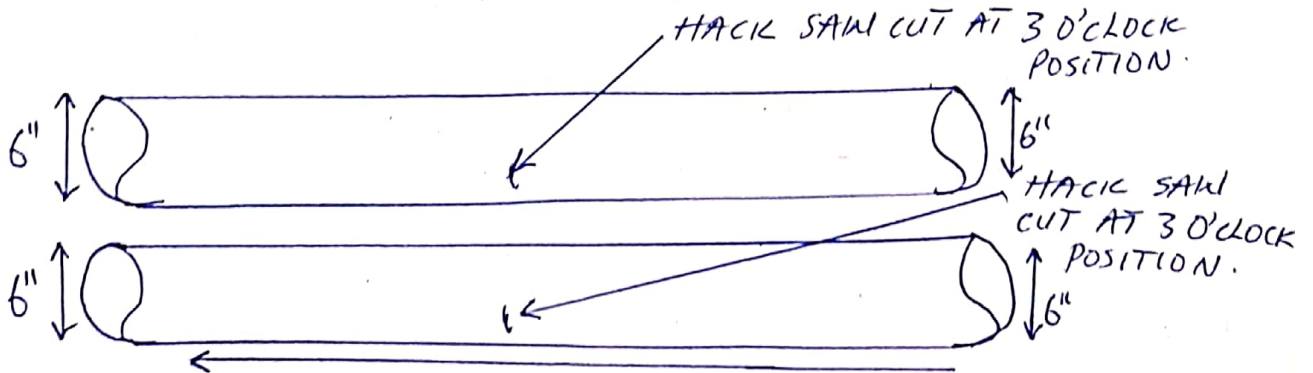
A SECTION OF 6" SEIBUO WELL 3 & 4 BULKLINE AT AGBI DIANA SHOWING 2 NO'S HACK SAW CUTS AT 3 O'CLOCK POSITIONS ON EACH LINE BY UNKNOWN PERSON(S).

FROM SEIBUO FIELD TO OPUKUSHI FLOW STATION

REPAIR BY CLAMPING
