# JOINT INVESTIGATION REPORT

INCIDENT NO: 2789154 JIV report S/N: 0623

1. Fountain Incident Number: 2789154 2. Type of incident\* OIL SPILL  
3. Name of Location 12" OGUTA - EGBEMA PIPELINE  
4. Name of nearest community UKWUGBA 5. State: IMO 6. LGA DHAJI - EGBEMA  
7. Production Facility/Installation OIL PIPELINE  
8. Asset Owner/Hub THE SHELL PETROLEUM DEVELOPMENT COMPANY OF NIGERIA LTD (SPDC) / PIPELINE

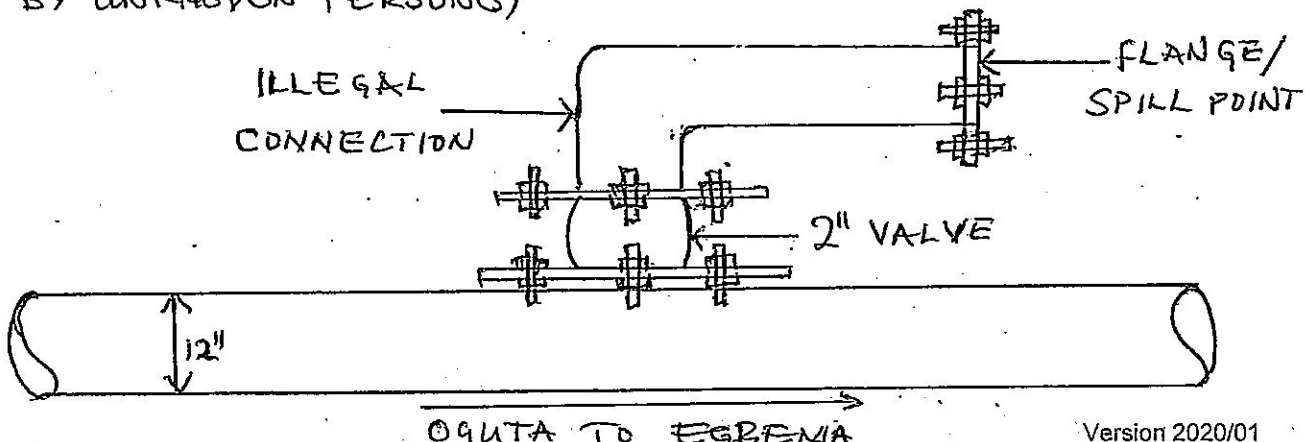
| <input checked="" type="checkbox"/> Crude oil theft (illegal bunkering) point, | <input type="checkbox"/> Saver-pit over flow | <input type="checkbox"/> Third party tampering with Clamp |

**E. GRAPHIC DESCRIPTION OF LEAK POINT** (while detailed description of the leak point should be contained in the leak report, overview sketch of the site should be added as appendix 1) A SECTION OF 12" OGUTA - EBREMA PIPELINE AT UKWUGBA SHOWING 2" VALVE ILLEGAL CONNECTION INSTALLED AT 12 O'CLOCK POSITION BY UNKNOWN PERSON(S)

SPILL RECOVERY / REPAIR BY CLAMPING
