INCIDENT NO: 2788229 JIV report S/N:000804

A. GENERAL INFORMATION:		
1. Fountain Incident Number: 278822	2. Type of inc	ident* CON DENSED GAS SPIL
3. Name of Location ESTUARY FL	DW STATION	FLARE
4. Name of nearest community OGHULHA	5. State: DELTA	6. LGA BURUTU

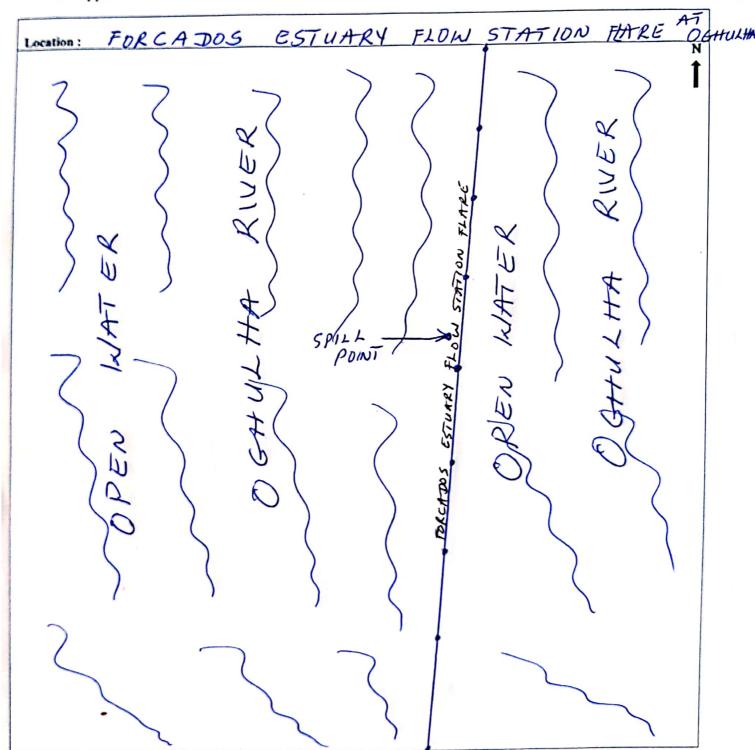
f. Appendix 1: Overview sketch of the site

INCIDENT NO: 27 88229 JIV report S/N: 00008^4 15. Was there any disruption to the investigation? [Y] [N]If yes to item 15 give brief description: 16. Was JIV delayed? Reason(s): ☐ Delayed Community Access Approval ☐ Security Challenges ☐ Access constraint due to terrain Others (specify) LOG-15TICS CONSTRAINTS. D. TYPE/NUMBERS OF PROPERTIES, IF ANY, FOUND WITHIN THE AREA OF SPREAD OF OIL 17. Structures / Properties Type of Structures Description Size Number Comments 18. Crops/Economic Trees S/N Type of crops Young Medium Matured Quantity Comments 19. Fish/Nets/Ponds S/N Fish/Nets/Ponds Description Quantity/Size Comments 20. Others (Specify) e.g. Animal Traps Others Description Quantity/Size Comments E. GRAPHIC DESCRIPTION OF LEAK POINT (while detailed description of the leak point should be contained in the leak report, overview sketch of the site should be added as appendix 1) SECTION OF ESTUARY FLOW STATION FLARE SYSTEM STACK SHOWING FAILED FLARE HEAD FLARE-SPILL BURNER PDINT
