Overview: Overview of incident environment of Estuary flow station flare at Ogulagha. Picture was taken during Joint Investigation of 1st December 2020.

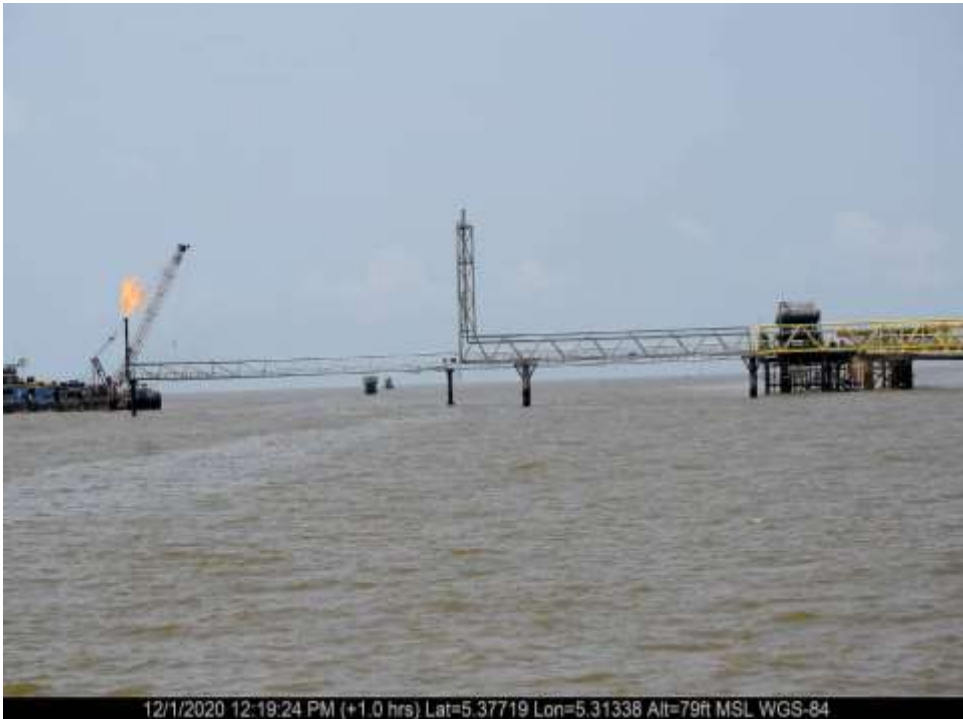
Close-up: Failed flare head on Estuary flow station flare at Ogulagha. Picture was taken during Joint Investigation of 1st December 2020.
