# JOINT INVESTIGATION REPORT

INCIDENT NO: 2771184 JIV report S/N:

1. Fountain Incident Number: 2771184 2. Type of incident\* OIL SPILL  
3. Name of Location 12" IMORIVER 2 - OGALE PIPELINE  
4. Name of nearest community IBIRIUKWU - ISIETIHOHA 5. State: ABIA 6. LGA UKWA WEST  
7. Production Facility/Installation CRUDE OIL PIPELINE  
8. Asset Owner/Hub THE SHELL PETROLEUM DEVELOPMENT COMPANY OF NIGERIA LIMITED / PIPELINE

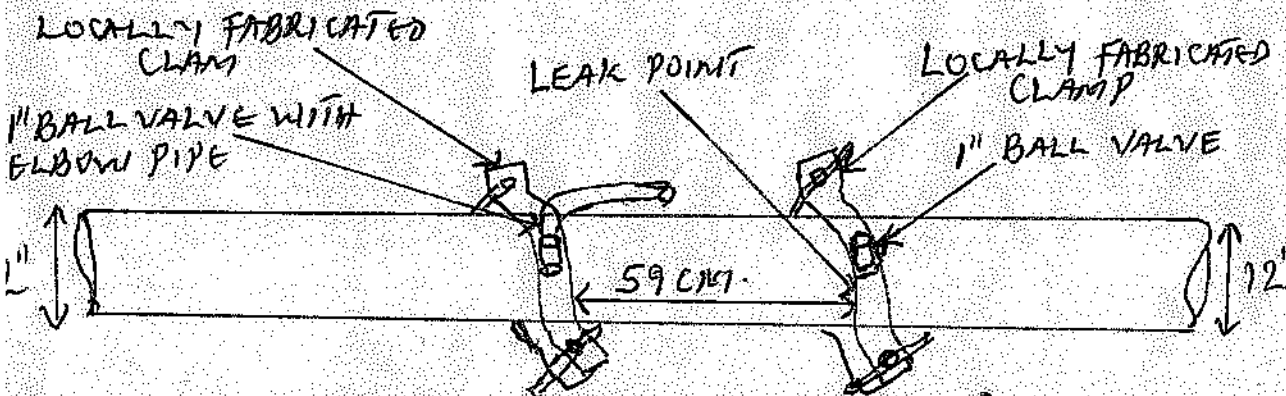
SECTION OF 12" IMORIVER 2 - OBALE PIPELINE AT IGIRUKWU - SITIONHA OWAZA STANDING 2 NOS OF CRUDE OIL THEFT POINTS INSTALLED AT 12 O'CLOCK POSITIONS BY UNKNOWN PERSONS.
