JOINT INVESTIGATION REPORT

INCIDENT NO: 2767793 JIV report S/N: 0694

A. GENERAL INFORMATION:

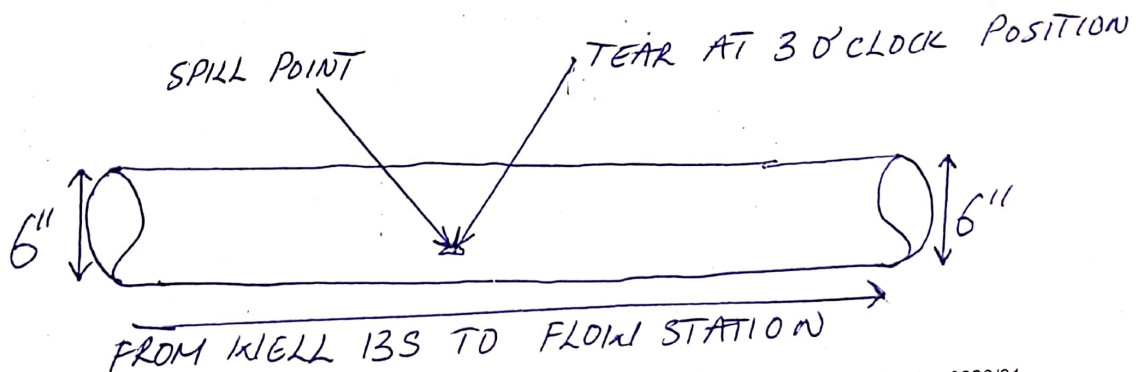
A SECTION OF 6" ESCRAVOS WELL 135 FLOWLINE AT ESCRAVOS SHOWING A TEAR AT 3 O'CLOCK POSITION.
