JOINT INVESTIGATION REPORT

INCIDENT NO: 2727729 JIV report S/N: 0610

1. Fountain Incident Number: 2727729 2. Type of incident* OIL SPILL
3. Name of Location 12" IMORIVER 2 - OGALA PIPELINE
4. Name of nearest community UMMOLOLO 5. State: ABIA 6. LGA UKWIA WEST
7. Production Facility/Installation CRUDE OIL PIPELINE
8. Asset Owner/Hub THE SHELL PETROLEUM DEVELOPMENT COMPANY OF NIGERIA LIMITED / PIPELINE

JIV ALONG 12" IMO RIVER - OGALE TRUNKLINE AT UMUOLOLO. Fid 2727729

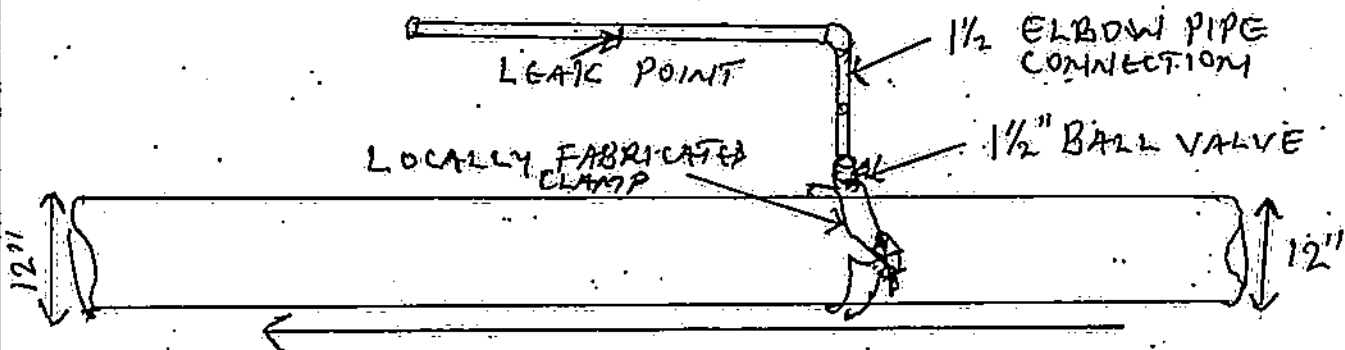
| <input checked="" type="checkbox"/> Crude oil theft (illegal bunkering) point, | <input type="checkbox"/> Saver-pit over flow | <input type="checkbox"/> Third-party tampering with Clamp |

SECTION OF 12" IMO RIVER 2 - OGALE PIPELINE AT UMUOLOLO SHOWING CRUDE OIL THEFT POINT INSTALLED AT 12 O' CLOCK POSITION BY UNKNOWN PERSON(S).

REPAIR WORK AND CRUDE OIL RECOVERY
ACTIVITIES ONGOING.
