Overview: Part of spill impact on Imo River 1 Well 44s Flowline at Igiriukwu Isi-Etithoha. Picture was taken during Joint Investigation on 15th September 2020.

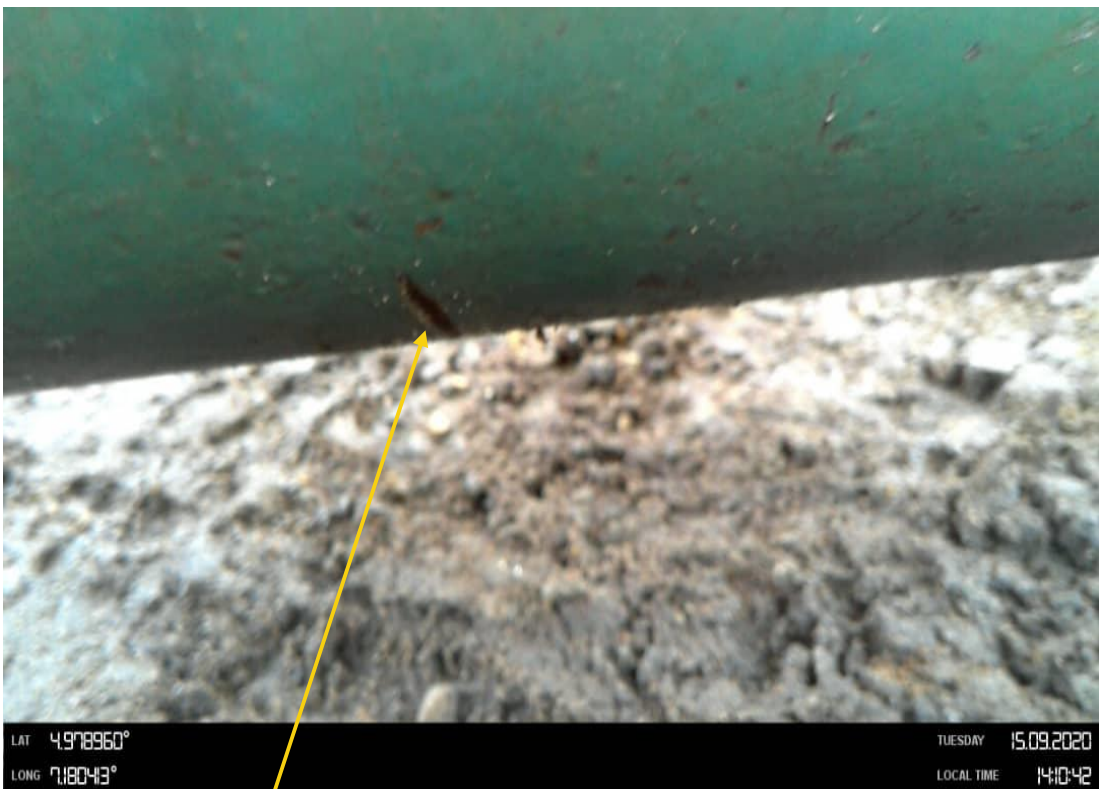
Close-up: 72mm Hacksaw cut at 5 to 6 o'clock position on Imo River 1 Well 44s Flowline at Igiriukwu Isi-Etithoha. Picture was taken during Joint Investigation on 15th September 2020.
