JOINT INVESTIGATION REPORT

INCIDENT NO: 2730748 JV report SN: 0583

1. Facility Incident Number 2730748 & Type of Incident FIRE / OIL SPILL
2. Name of Location 8th ISIMIRI - IMO RIVER GAZ DELIVERAYLINE
3. Name of nearest community UNDELECHI near ABIA & LGA UKWA-NWEST
4. Production Facility Name OIL PIPELINE
5. Asset Owner Name THE SHELL PETROLEUM DEVELOPMENT COMPANY OF NIGERIA LIMITED / PIPELINE

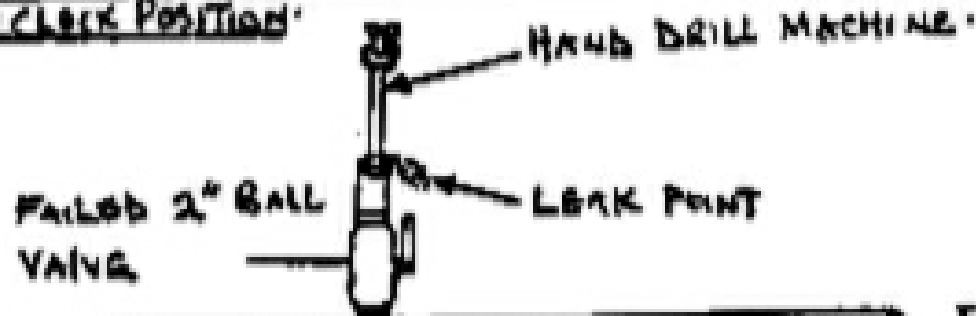
ISIMIRI - IND RIVER PIPELINE

| <input checked="" type="checkbox"/> Weld failure (crack) hot tap valve | <input type="checkbox"/> Flare Clang | <input type="checkbox"/> Moving Pipeline/flow line |

SECTIONAL VIEW OF 8" ISIMIRI - IND RIVER GATE DRIVEWAY LINE AT UMUELECHI SHOWING: A 2" FAILED BALL VALVE INSTALLED AT 12' O'CLOCK POSITION.
