JOINT INVESTIGATION REPORT

INCIDENT NO: 2911857 JIV report S/N: 0000800

1. Fountain Incident Number: 2911857 2. Type of incident* OIL SPILL
3. Name of Location 14" OKORDIA - RUMUKEPE PIPELINE
4. Name of nearest community IKARAMA 5. State BAYELSA LGA YENAGOA
7. Production Facility/Installation PIPELINE
8. Asset Owner/Hub THE SHELL PETROLEUM DEVELOPMENT COMPANY OF NIGERIA LIMITED (SPDC) / PIPELINE

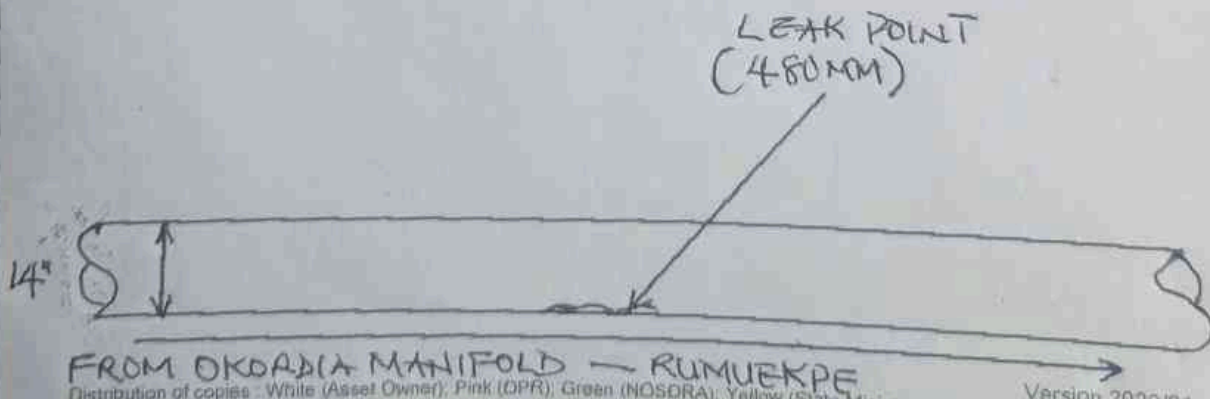
| <input checked="" type="checkbox"/> Tear (<u>480MM</u>) | | |

E. GRAPHIC DESCRIPTION OF LEAK POINT (while detailed description of the leak point should be contained in the leak report, overview sketch of the site should be added as appendix 1) **A SECTION OF 14" OKORDIA - RUMUEKPE PIPELINE AT IKARAMA SHOWING A TEAR (480MM) AT 6 O'CLOCK POSITION**

REPAIR ONGOING BY SECTIONAL REPLACEMENT.

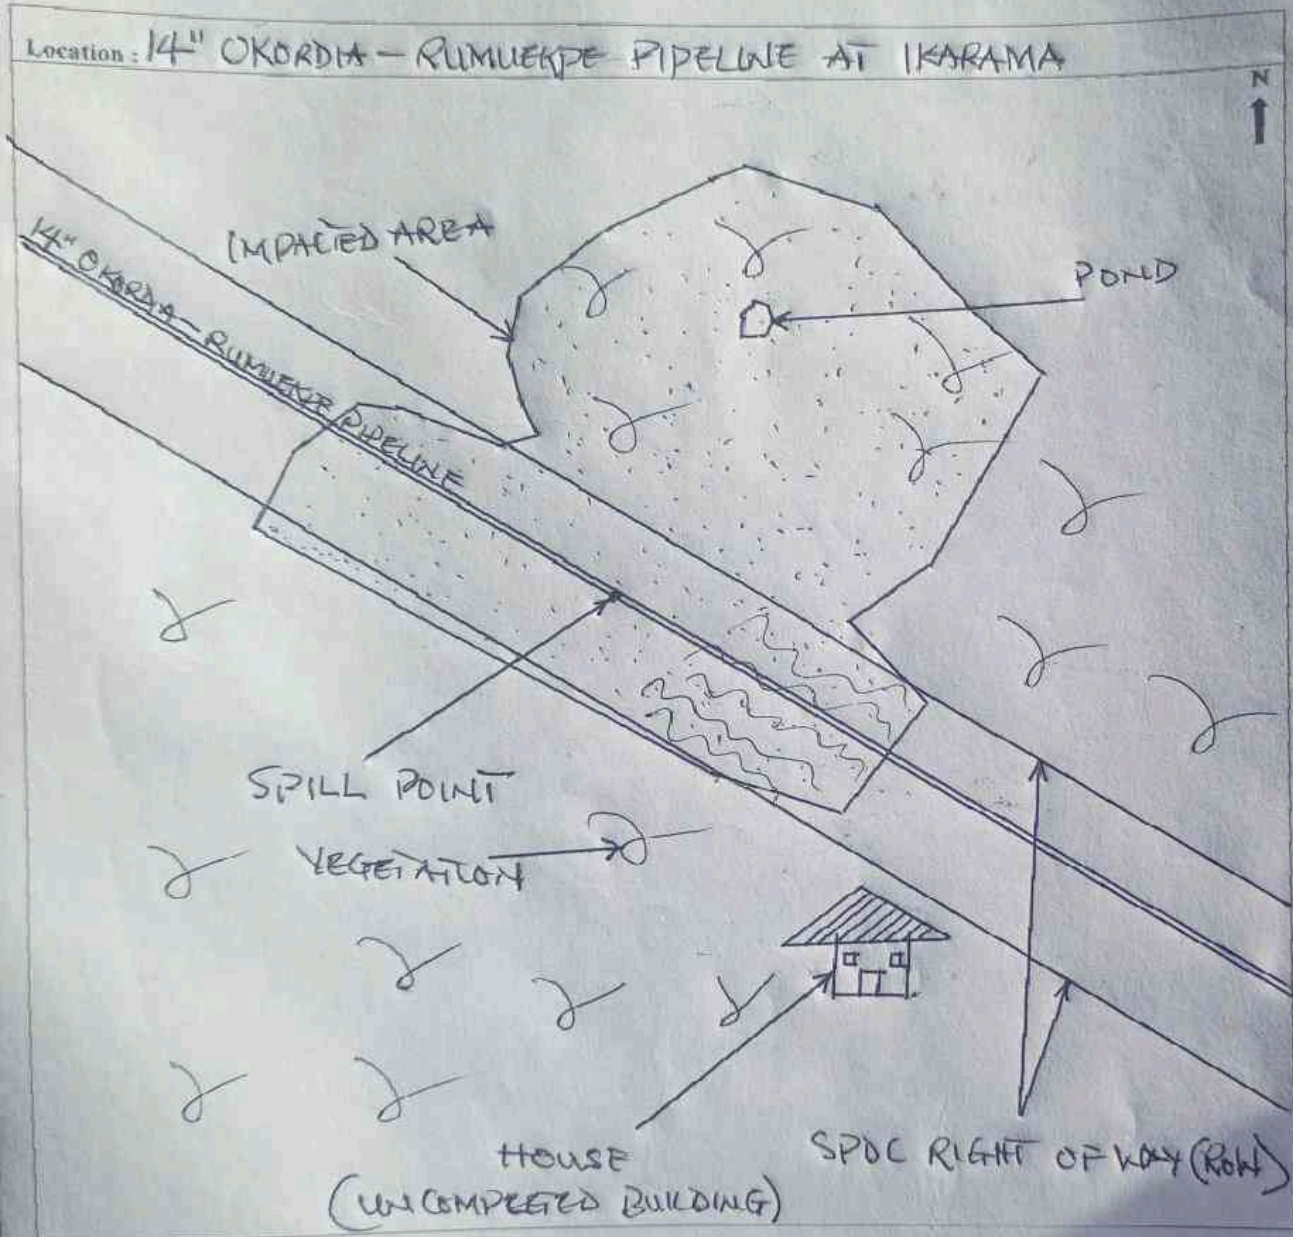
f. Appendix 1: Overview sketch of the site

- Total calculated area of impact (Ha) 1.34 HA
- Impact within SPDC R.O.W YES
- Impact outside SPDC R.O.W YES
