# JOINT INVESTIGATION REPORT

INCIDENT NO: 2928979 JIV report S/N: 0000770

1. Fountain Incident Number: 2928979 2. Type of incident\* OIL SPILL  
3. Name of Location 16" EGBEMA - ASSA PIPELINE  
4. Name of nearest community EKUGBA 5. State: IMO 6. LGA EGBEMA-OHAJI  
7. Production Facility Installation PIPELINE  
8. Asset Owner/Hub THE STEEL PETROLEUM DEVELOPMENT COMPANY OF NIGERIA LIMITED (SPDC)/PIPELINE

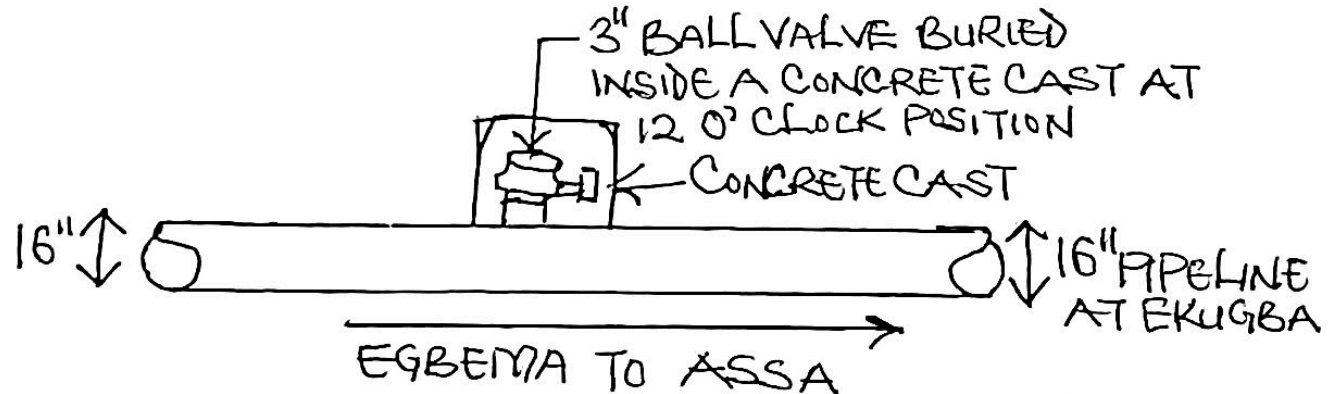
**E. GRAPHIC DESCRIPTION OF LEAK POINT** (while detailed description of the leak point should be contained in the leak report, overview sketch of the site should be added as appendix 1)

| <input checked="" type="checkbox"/> Crude oil theft (illegal bunkering) point, | <input type="checkbox"/> Saver-pit over flow | <input type="checkbox"/> Third party tampering with Clamp |

A SECTION OF 16" EGBEMA-ASSA PIPELINE AT EKUGBA SHOWING A 3" BALL VALVE BURIED IN A CONCRETE COATING AT 12 O' CLOCK POSITION INSTALLED BY UNKNOWN PERSON(S).

REPAIR BY CLAMPING
