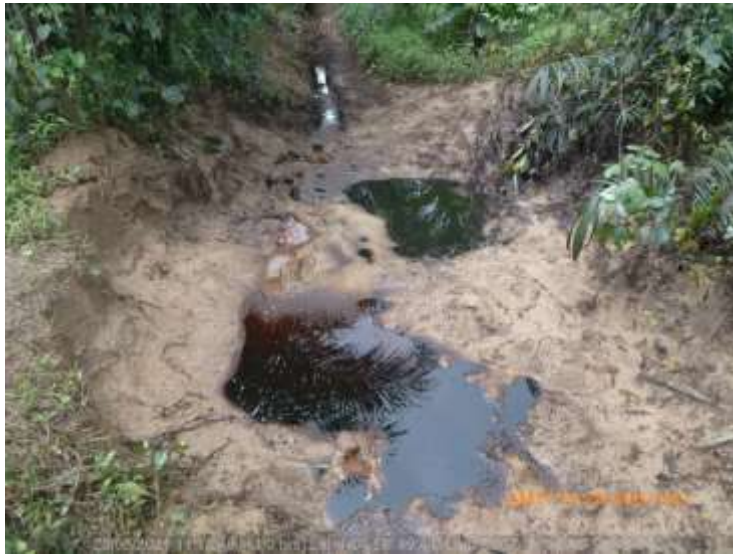
Overview: Part of spill impact on 4" Imo River 3 Well 01T Flowline at Owaza. Picture was taken during Joint Investigation of 28<sup>th</sup> August 2021.

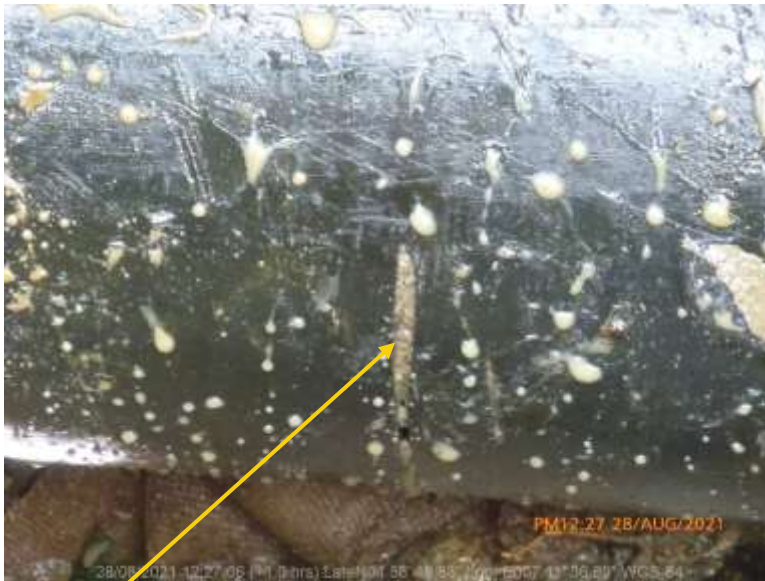
Close-up: 8cm Hacksaw cut from 1 to 3 o'clock position on 4" Imo River 3 Well 01T Flowline at Owaza. Picture was taken during Joint Investigation of 28<sup>th</sup> August 2021.
