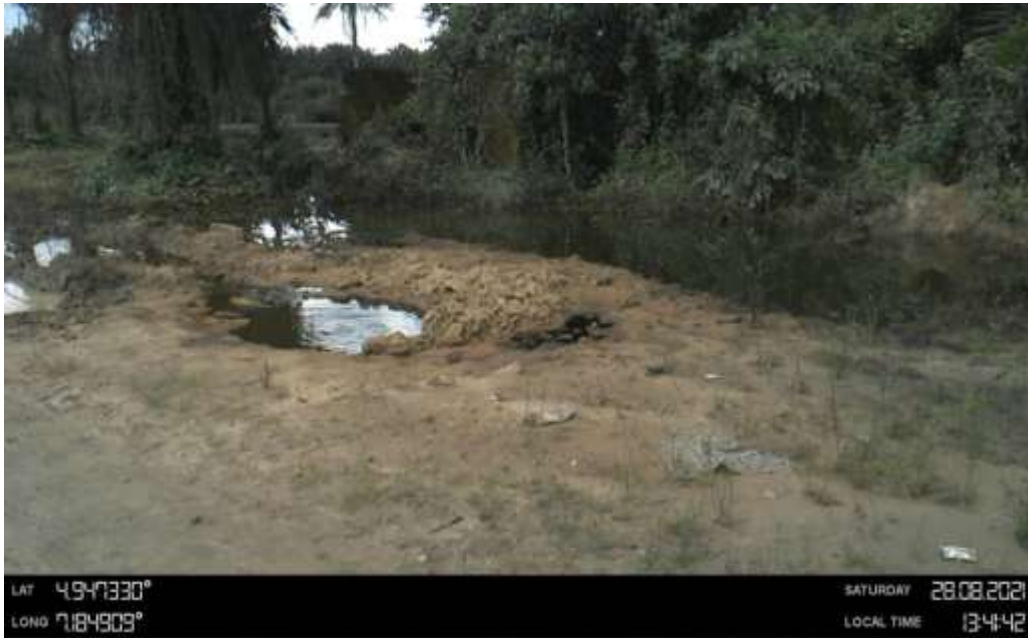
Overview: Part of spill impact on 12" Imo River 2 – Ogale Pipeline at Umulolo. Picture was taken during Joint Investigation of 28<sup>th</sup> August 2021.

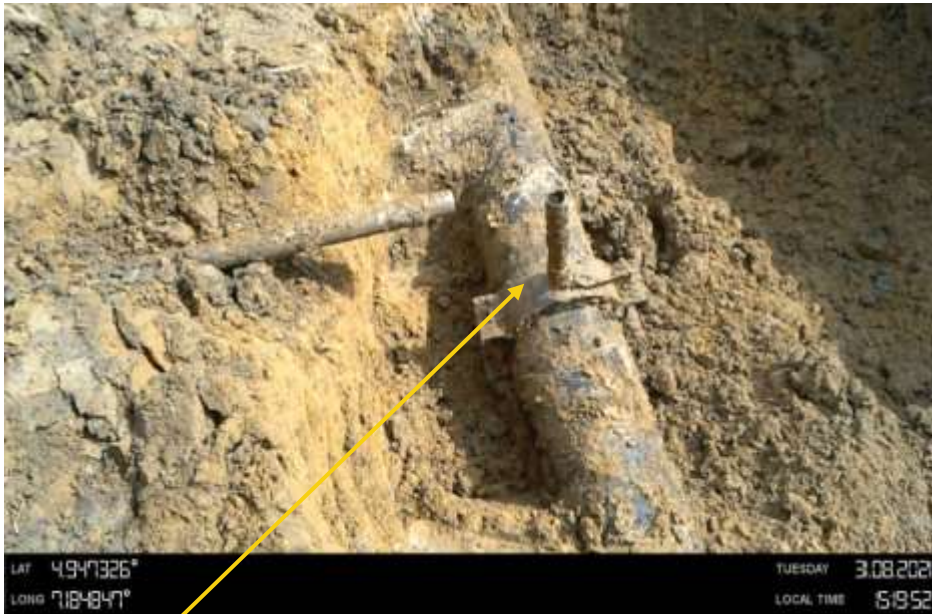
Close-up: Crude oil theft point installed at 12 o'clock position on 12" Imo River 2 – Ogale Pipeline at Umulolo. Picture was taken during Joint Investigation of 28<sup>th</sup> August 2021.
