JOINT INVESTIGATION REPORT

INCIDENT NO: 3007363 JIV report S/N: 0001007

1. Fountain Incident Number: 3007363 2. Type of incident* OIL SPILL
3. Name of Location FORCADOS SINGLE POINT MOORING 2
4. Name of nearest community OGULAGHA 5. State: DELTA 6. LGA BURUTU
7. Production Facility/Installation CRUDE OIL EXPORT FACILITY
8. Asset Owner/Hub THE SHELL PETROLEUM DEVELOPMENT COMPANY OF NIGERIA LIMITED (SPDC) WEST ASSET.

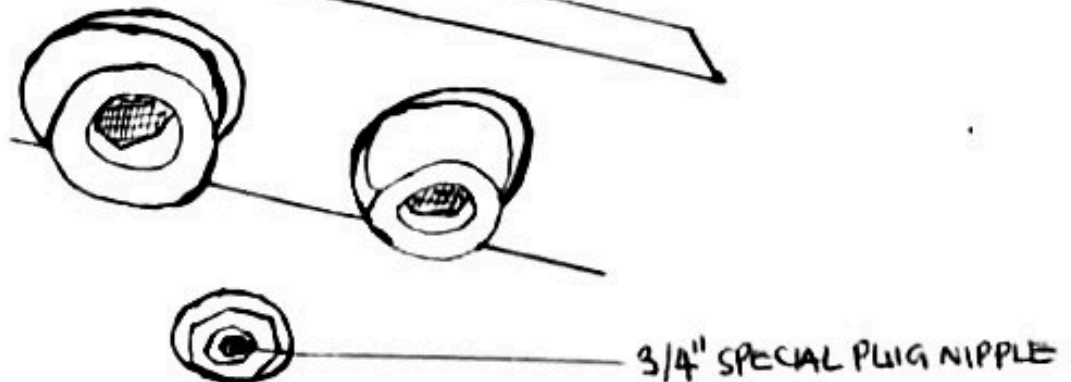
Additional observations around the spill point: THE JOINT INVESTIGATION TEAM OBSERVED NO TRACE OF CRUDE OIL AROUND THE SINGLE POINT MOORING 2 AT THE TIME OF JOINT INVESTIGATION VISIT.

- Others (specify) SPECIAL PLUG FAILURE

E. GRAPHIC DESCRIPTION OF LEAK POINT (while detailed description of the leak point should be contained in the leak report, overview sketch of the site should be added as appendix 1) A SECTION OF FOUCADOS SINGLE POINT MOORING 2 AT OGULAGHA SHOWING FAILED SPECIAL PLUG NIPPLE.

REPAIRS ON THE PRODUCT DISTRIBUTION UNITS (PDU) IS ONGOING
