JOINT INVESTIGATION REPORT

INCIDENT NO: 3016578 JIV report S/N: 0000961

1. Fountain Incident Number: 3016578 2. Type of incident* OIL SPILL
3. Name of Location 12" IMO RIVER 2 - OGALE PIPELINE
4. Name of nearest community OGALE 5. State: RIVERS 6. LGA ELEME
7. Production Facility/Installation CRUDE OIL PIPELINE
8. Asset Owner/Hub THE STELL PETROLEUM DEVELOPMENT COMPANY OF NIGERIA LIMITED (SPDC)/PIPELINE

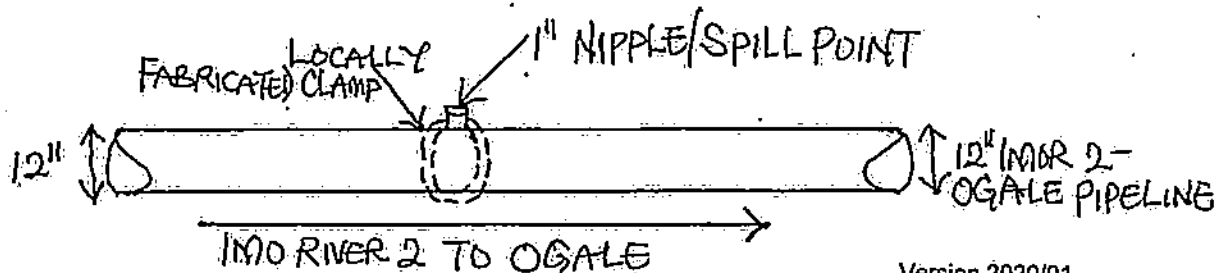
| <input checked="" type="checkbox"/> Crude oil theft (illegal bunkering) point, | <input type="checkbox"/> Saver-pit over flow | <input type="checkbox"/> Third party tampering with Clamp |

E. GRAPHIC DESCRIPTION OF LEAK POINT (while detailed description of the leak point should be contained in the leak report, overview sketch of the site should be added as appendix 1) A SECTION OF 12" IMR RIVER 2 - OGALE PIPELINE AT OGALE SHOWING A 1" PIPELINE INSTALLED AT 12 O'CLOCK POSITION WITH A LOCALLY FABRICATED CLAMP BY UNKNOWN PERSON(S)

REPAIR BY CLAMPING

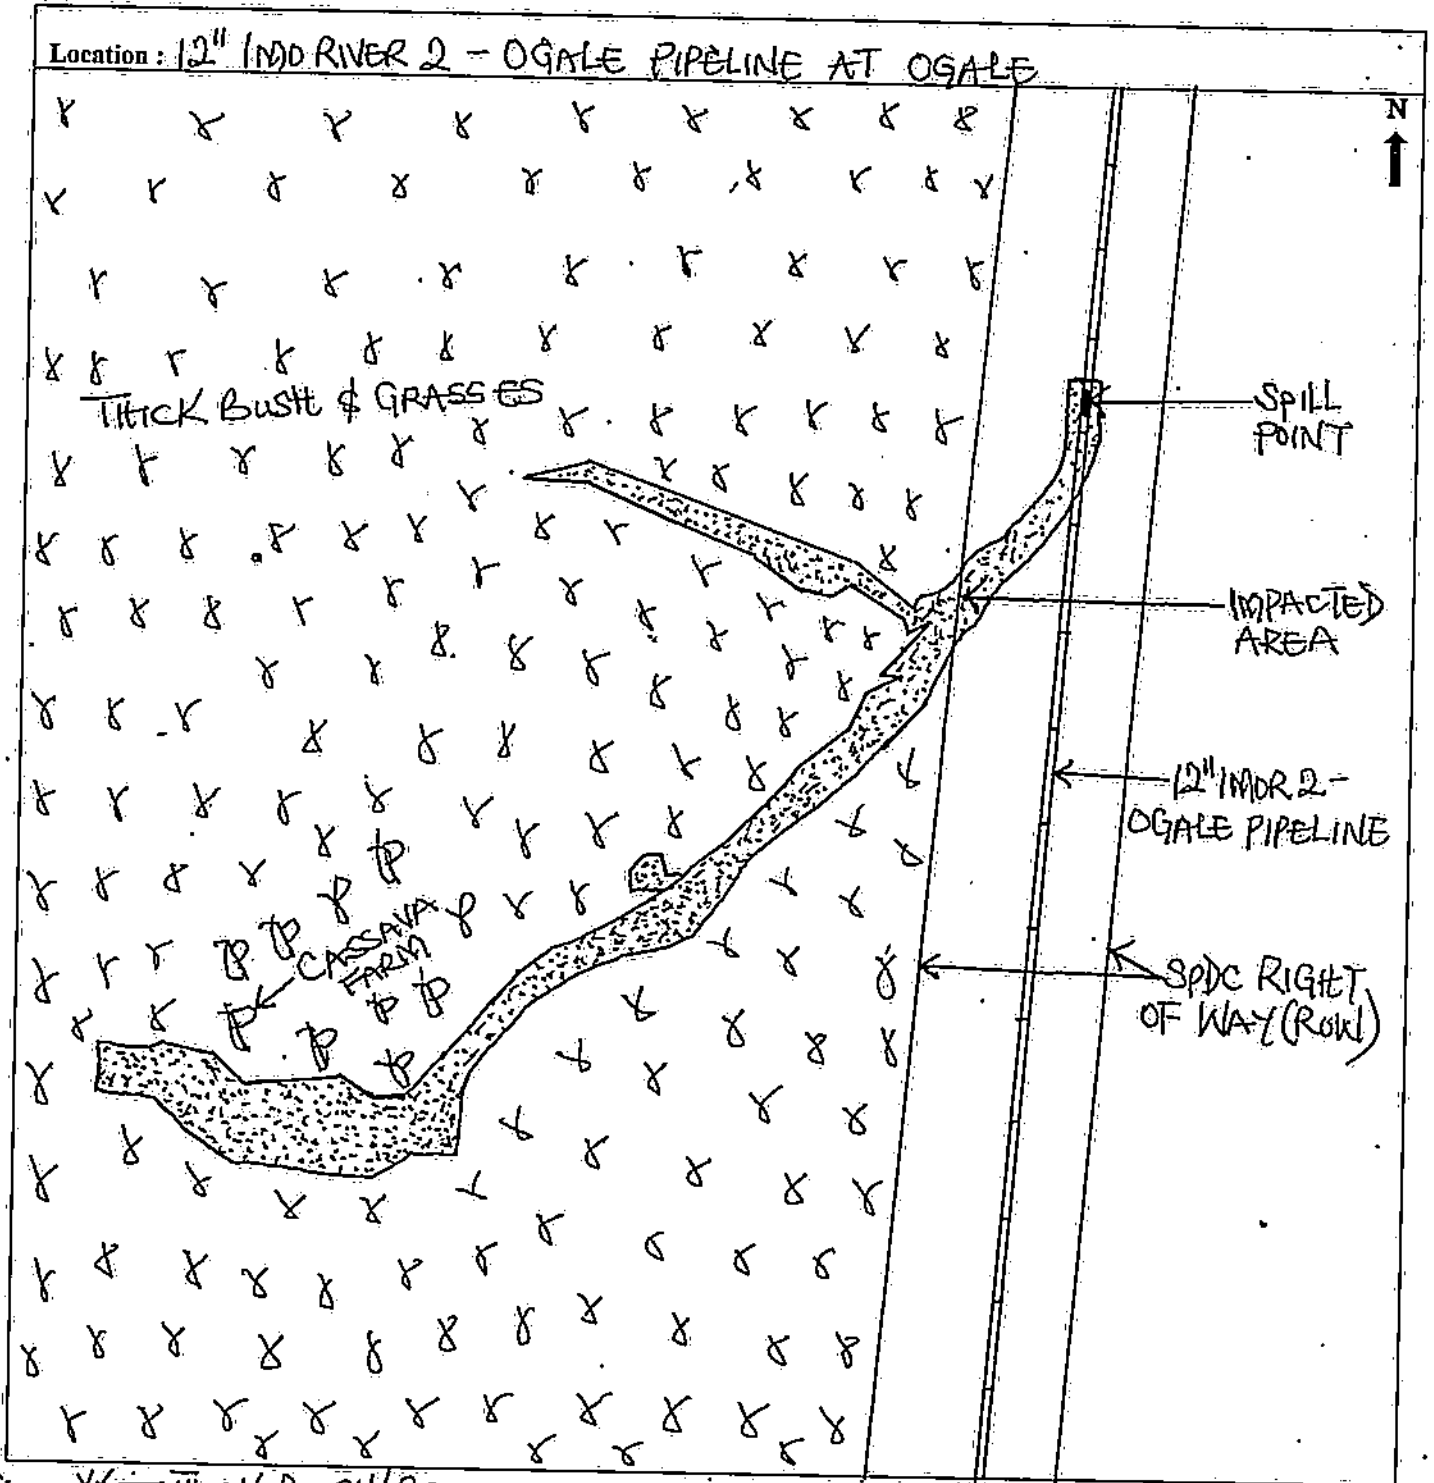
f. Appendix 1: Overview sketch of the site.

← THICK BUSH/GRASSES
← CASSAVA FARM.
