JOINT INVESTIGATION REPORT

INCIDENT NO: 3009577 JIV report S/N: 0000900

1. Fountain Incident Number: 3009577 2. Type of incident* OIL SPILL
3. Name of Location 28" BOMU - BONNY TRANS NIGER PIPELINE
4. Name of nearest community OWOKIRI 5. State: RIVERS 6. LGA ANDONI
7. Production Facility/Installation OIL PIPELINE
8. Asset Owner/Hub THE SHELL PETROLEUM DEVELOPMENT COMPANY OF NIGERIA LIMITED PIPELINE

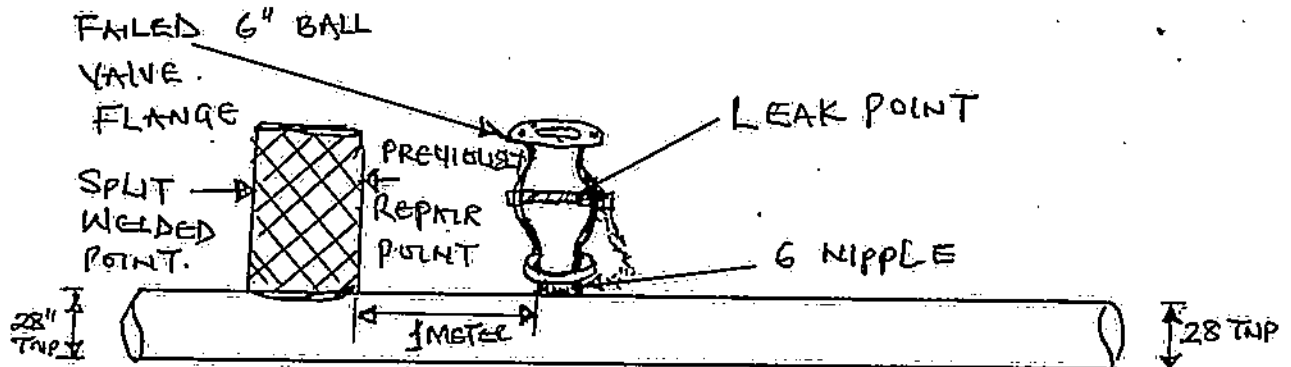
Additional observations around the spill point: THE JOINT INVESTIGATION TEAM OBSERVED A REPAIRED POINT BY SPLIT WELDING, ONE METER (1m) AWAY FROM THE CURRENT INCIDENT.

| <input checked="" type="checkbox"/> Failed Weld-on illegal hot tap valve | <input type="checkbox"/> Failed Clamp, | <input type="checkbox"/> Missing Pipeline/Flowline |
| <input checked="" type="checkbox"/> Crude oil theft (illegal bunkering) point, | <input type="checkbox"/> Saver-pit over flow | <input type="checkbox"/> Third party tampering with Clamp |

SECTIONAL VIEW OF 28" BOMU-BONNY TRANS NIGER PIPELINE AT OWOKIRI SHOWING A FAILED 6" BALL VALVE FLANGE INSTALLED AT 12'O CLOCK POSITION.

REPAIR WORK BY SPLIT WELDING ON-GOING

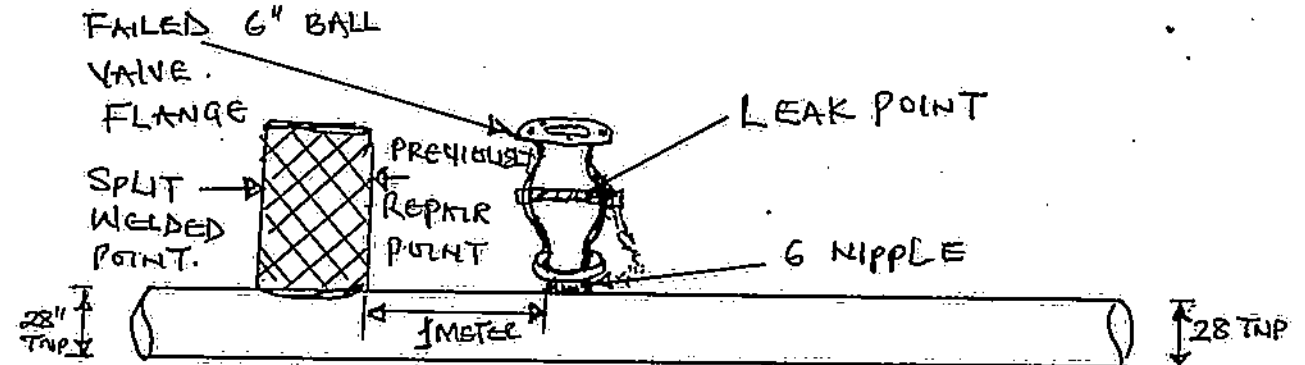
SECTIONAL VIEW OF 28" BOMU-BONNY TRANS NIGER PIPELINE AT OWOKIRI SHOWING A FAILED 6" BALL VALVE FLANGE INSTALLED AT 12'O CLOCK POSITION.

REPAIR WORK BY SPLIT WELDING ON-GOING
