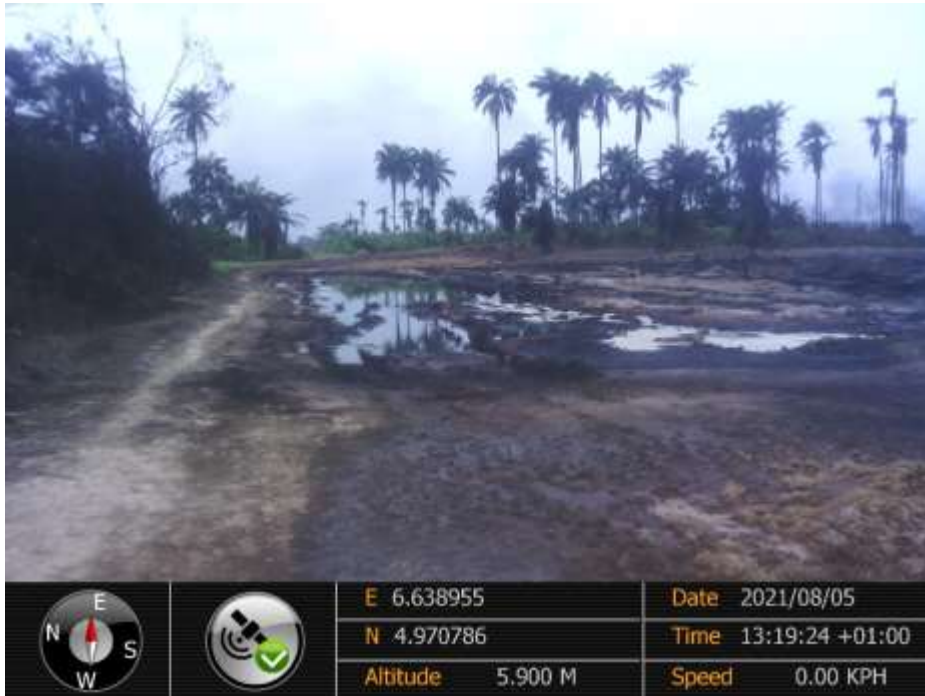
Overview: Part of spill impact on 20" Kolocreek Pipeline at Okporowo.  
 Picture was taken during Joint Investigation of 5<sup>th</sup> August 2021.

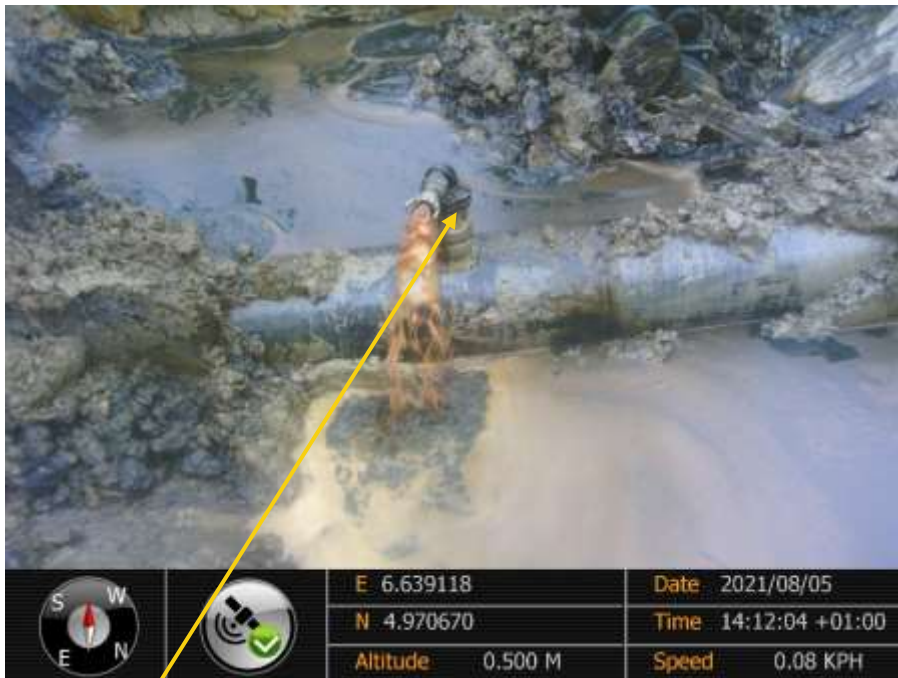
Close-up: 3" ball valve with 2" extension pipe installed at 12 o'clock position on 20" Kolocreek Pipeline at Okporowo. Picture was taken during Joint Investigation of 5<sup>th</sup> August 2021.
