# JOINT INVESTIGATION REPORT

INCIDENT NO: 3005417 JIV report S/N: 0000916

1. Fountain Incident Number: 3005391 3005417 2. Type of incident\* OIL SPILL/FIRE  
3. Name of Location 20" KOLO CREEK PIPELINE  
4. Name of nearest community OKPOROWO 5. State: RIVERS 6. LGA AKHADA EAST  
7. Production Facility/Installation PIPELINE  
8. Asset Owner/Hub THE SHELL PETROLEUM DEVELOPMENT COMPANY OF NIGERIA LIMITED (SPDC)/PIPELINE

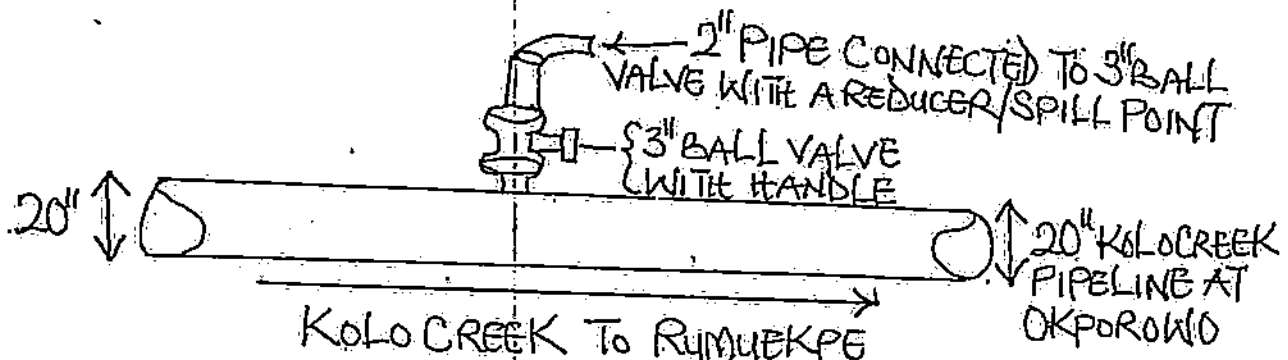
**E. GRAPHIC DESCRIPTION OF LEAK POINT** (while detailed description of the leak point should be contained in the leak report, overview sketch of the site should be added as appendix 1)

THE SPILL WAS ACCOMPANIED BY FIRE IT ALSO SHARES COMMON BOUNDRIES WITH ILLEGAL REFINARY. IT IS ALSO CLOSE TO AN ILLEGAL REFINARY.

A SECTION OF 20" KOLO CREEK PIPELINE AT OKPOROKO SHOWING A 3" BALL VALVE WITH 2" EXTENSION PIPE INSTALLED AT 12 O' CLOCK POSITION BY UNKNOWN PERSON(S).

REPAIR BY CLAMPING
