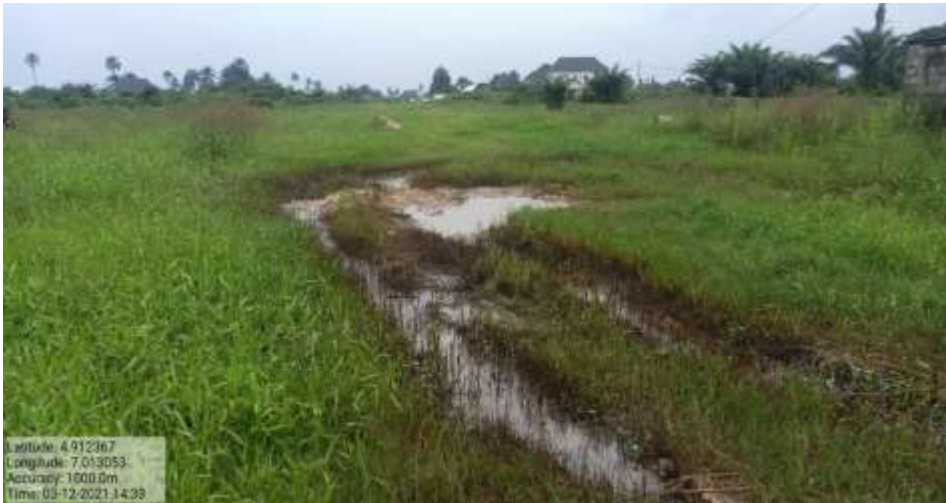
Overview: Part of spill impact on 36" Bomu Bonny Pipeline at Eneka.
Picture was taken during Joint Investigation of 3rd December 2021.

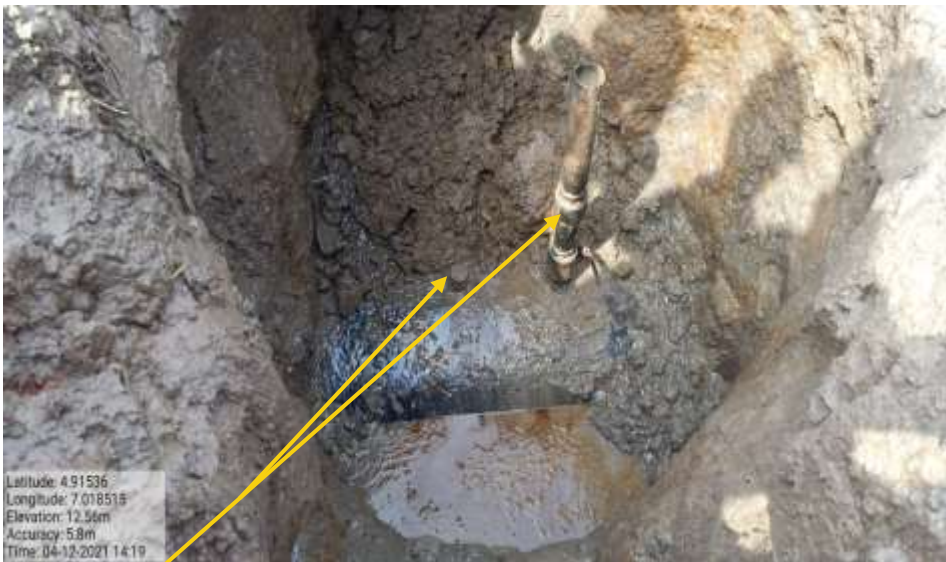
Close-up: 2inch ball valve and 2inch nipple with a distance of 0.2m apart installed at 12 o'clock position on 36" Bomu Bonny Pipeline at Eneka.
Picture was taken during Joint Investigation of 4th December 2021.
