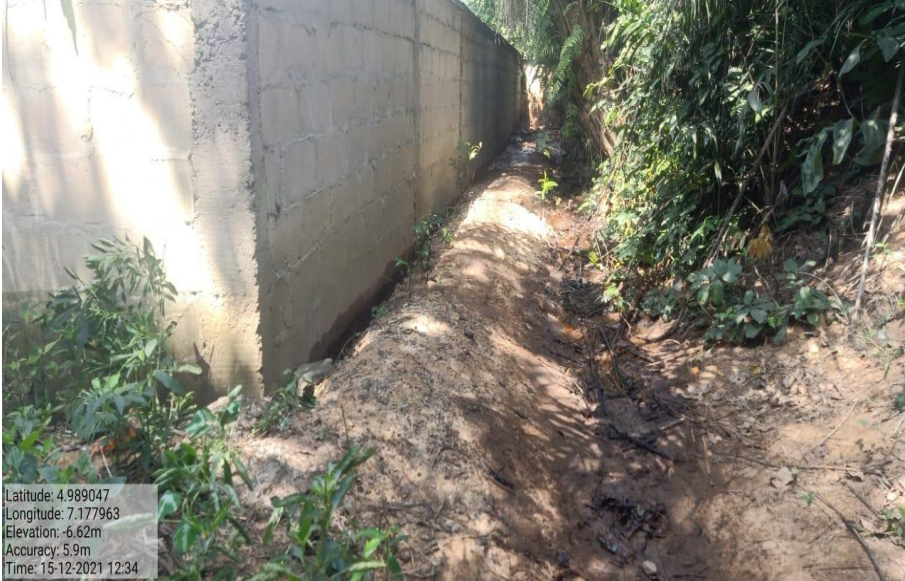
Overview: Part of spill impact on 4" Imo River Well 64L Flowline at Igiriukwu-Owaza.
Picture was taken during Joint Investigation on 15th December 2021.

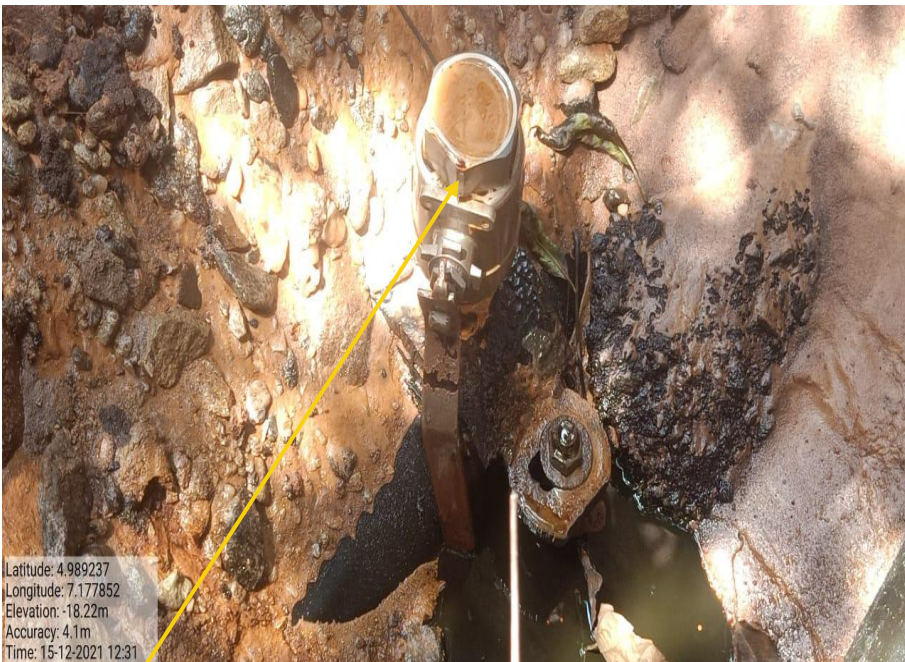
Close-up: 2" Ball valve attached to a local fabricated clamp installed at 12 o'clock position on 4" Imo River Well 64L Flowline at Igiriukwu-Owaza.
Picture was taken during Joint Investigation on 15th December 2021.
