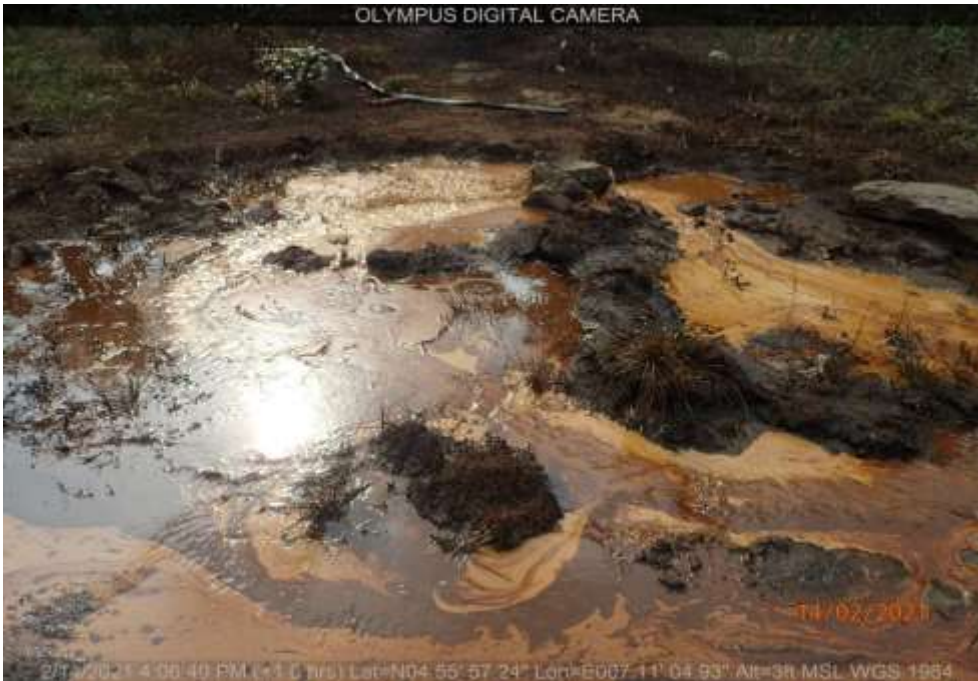
Overview: Part of spill impact on 12inch Imo River Ogale Pipeline . Picture was taken during Pre-Joint Investigation of 14<sup>th</sup> February 2021.

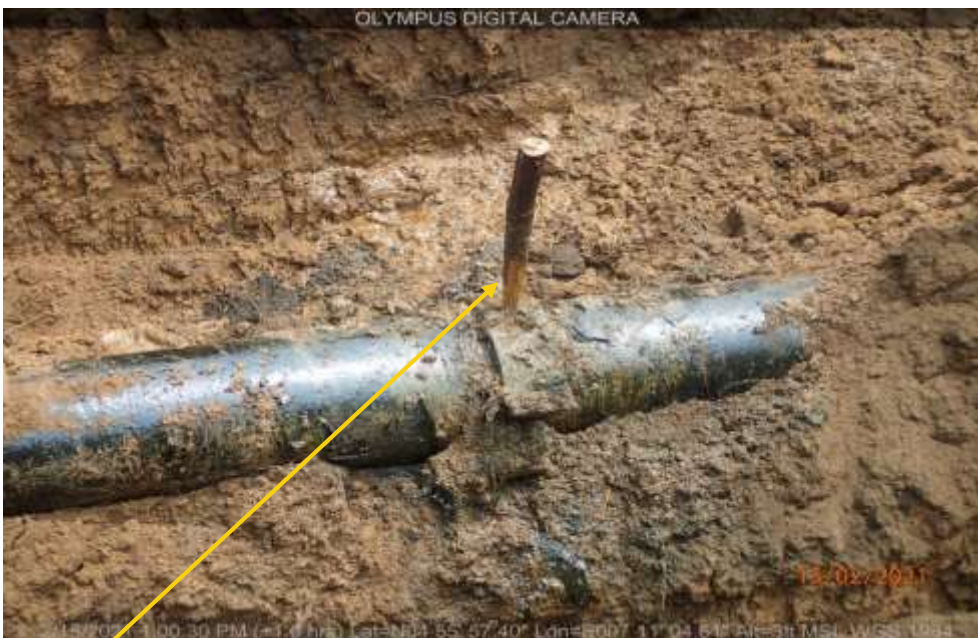
Close-up: Plugged 2inch Crude oil theft point installed at 12 o'clock position on 12inch Imo River Ogale Pipeline . Picture was taken during Joint Investigation of 15<sup>th</sup> February 2021.
