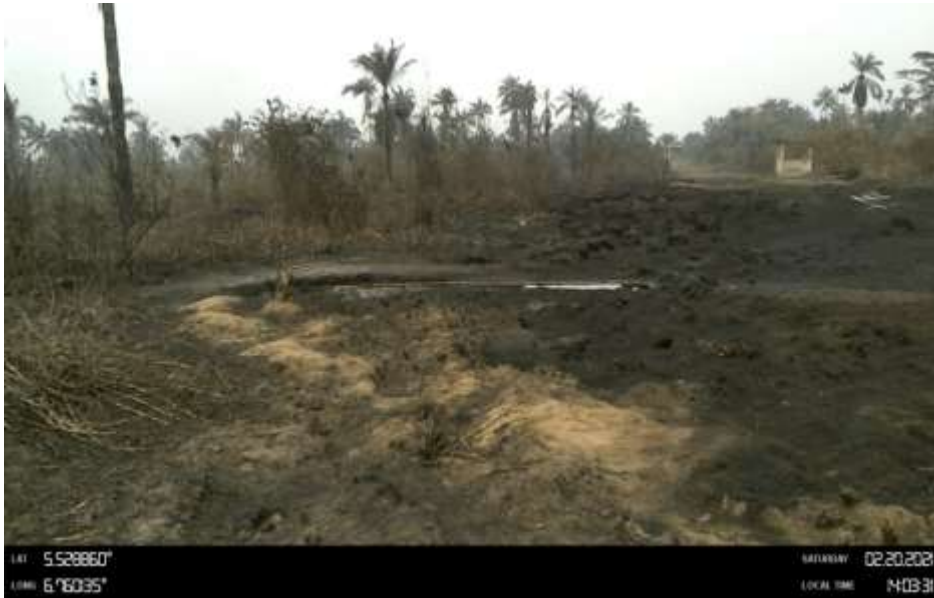
Overview: Part of spill impact on 16inch Assa Egbema Pipeline at Obiakpu . Picture was taken during Joint Investigation of 20<sup>th</sup> February 2021.

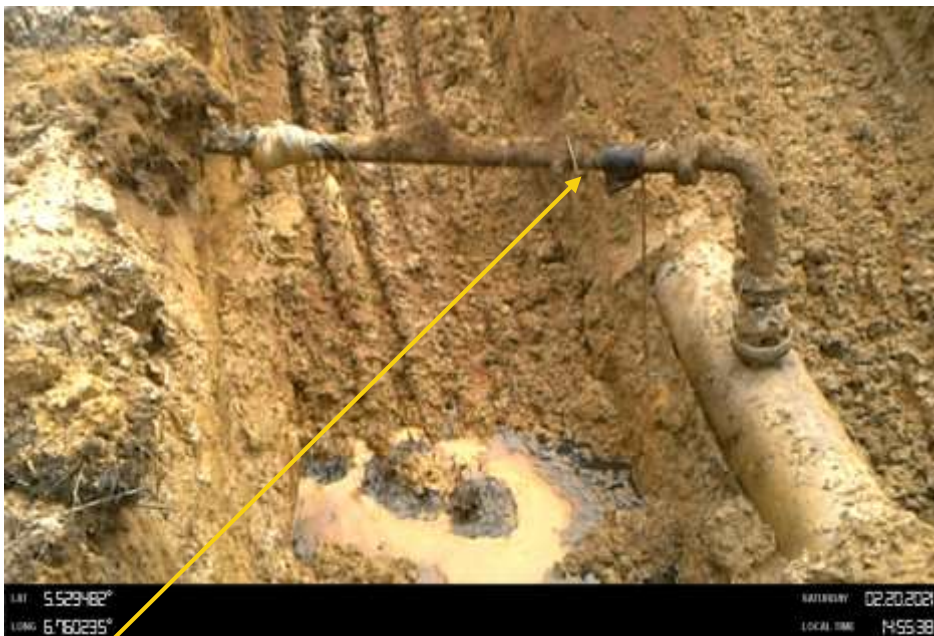
Close-up: Crude oil theft point installed at 12 o'clock position on 16inch Assa Egbema Pipeline at Obiakpu . Picture was taken during Joint Investigation of 20<sup>th</sup> February 2021.
