JOINT INVESTIGATION REPORT

INCIDENT NO: 2864074 JIV report S/N: 0000778

1. Fountain Incident Number: 2864074 2. Type of incident* OIL SPILL
3. Name of Location 16" EGBEMA - ASSA PIPELINE
4. Name of nearest community OBIAKPU 5. State: IMO 6. LGA OHAJI - EGBEMA
7. Production Facility/Installation OIL PIPELINE
8. Asset Owner/Hub THE SHELL PETROLEUM DEVELOPMENT COMPANY OF NIGERIA LIMITED / PIPELINE

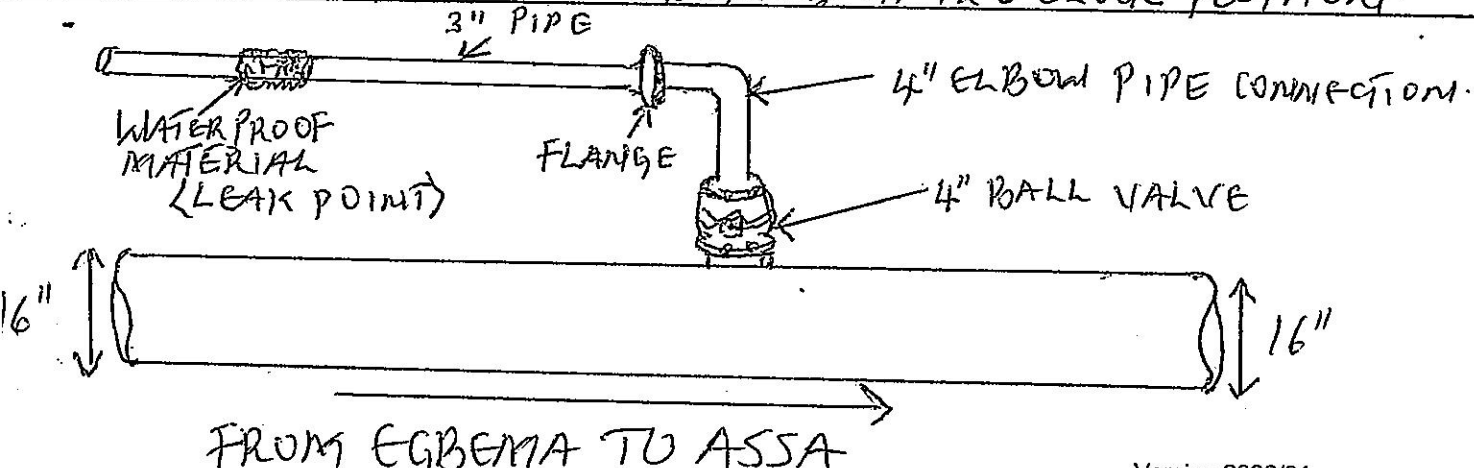
| <input checked="" type="checkbox"/> Failed Weld-on illegal hot tap valve | <input type="checkbox"/> Failed Clamp, | <input type="checkbox"/> Missing Pipeline/Flowline |
| <input checked="" type="checkbox"/> Crude oil theft (illegal bunkering) point, | <input type="checkbox"/> Saver-pit over flow | <input type="checkbox"/> Third party tampering with Clamp |

SECTION OF 16" EGBEMA-ASSA PIPELINE AT OBIAKPU SHOWING CRUDE OIL THEFT POINT INSTALLED AT 12 O'LOCK POSITION.

CRUDE OIL RECOVERY AND REPAIR ACTIVITIES ARE ONGOING.

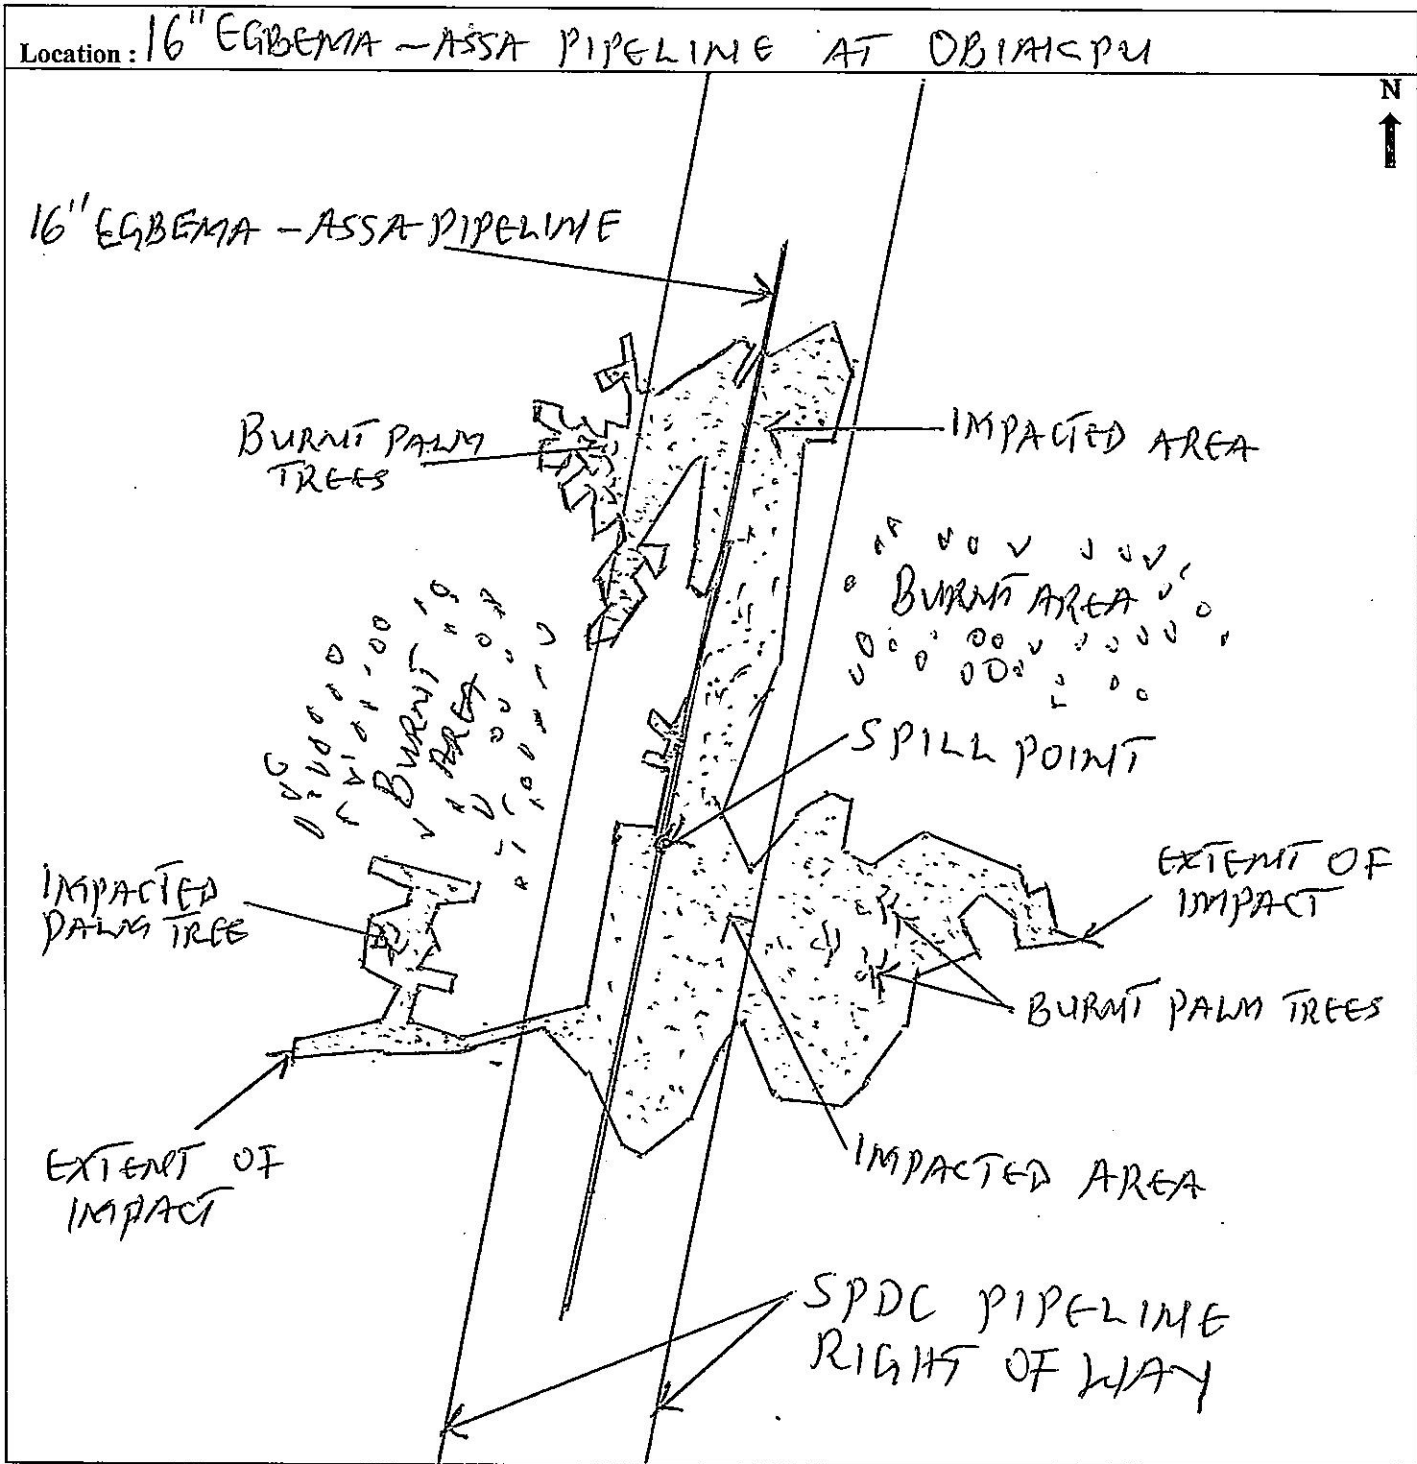
f. Appendix 1: Overview sketch of the site

BURNT AREA WAS OBSERVED.

- Total calculated area of impact (Ha) 0.73 Ha
- Impact within SPDC R.O.W YES
- Impact outside SPDC R.O.W YES
