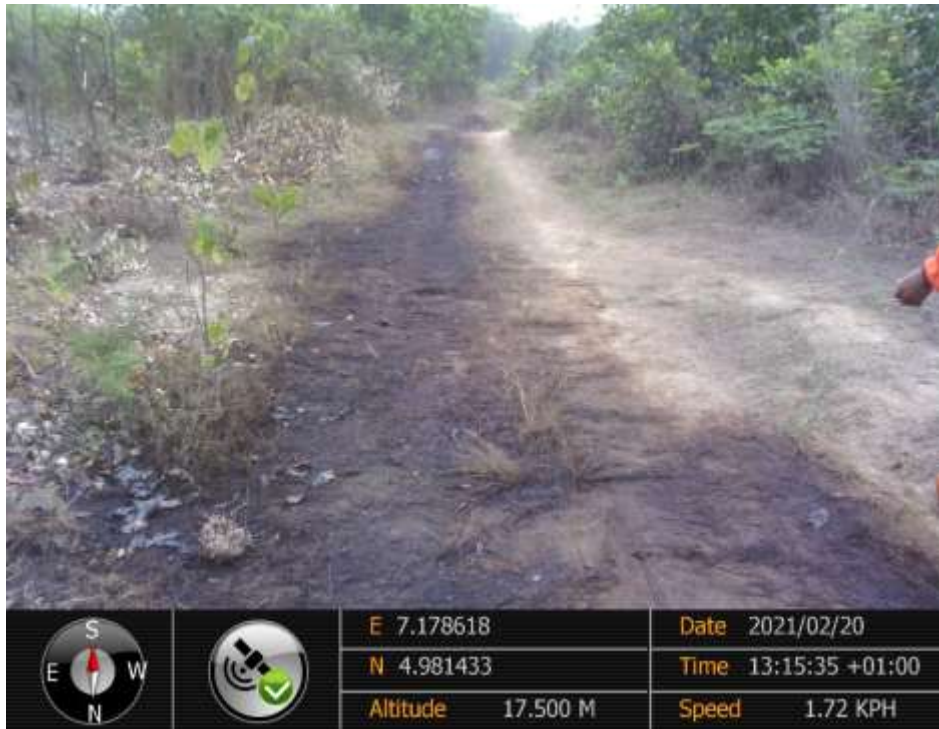
Overview: Part of spill impact on 6inch Imo River Well 26s Flowline at Owaza. Picture was taken during Joint Investigation of 20th February 2021.

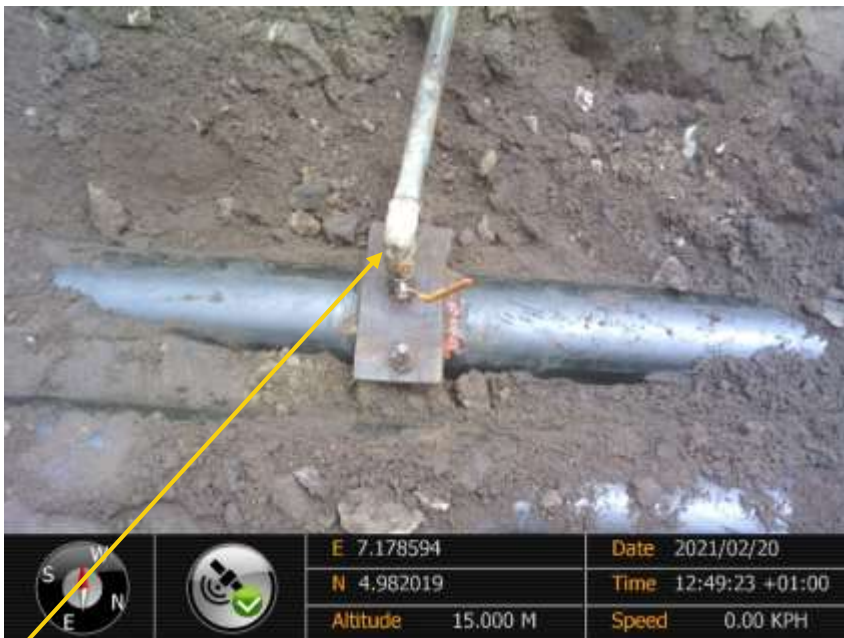
Close-up: 1.5inch Crude oil theft valve installed at 12 o'clock position on 6inch Imo River Well 26s Flowline at Owaza. Picture was taken during Joint Investigation of 20th February 2021.
