JOINT INVESTIGATION REPORT

INCIDENT NO: 2825128 JIV report S/N: 0744

1. Fountain Incident Number: 2825128 2. Type of incident* OIL SPILL
3. Name of Location 8° NKALI-IMOR 2 DELIVERY LINE (DL)
4. Name of nearest community ODAGWA 5. State: RIVERS 6. LGA ETCITE
7. Production Facility/Installation PIPELINE
8. Asset Owner/Hub THE SHELL PETROLEUM DEVELOPMENT COMPANY OF NIGERIA LIMITED LIMITED (SPDC)/PIPELINE

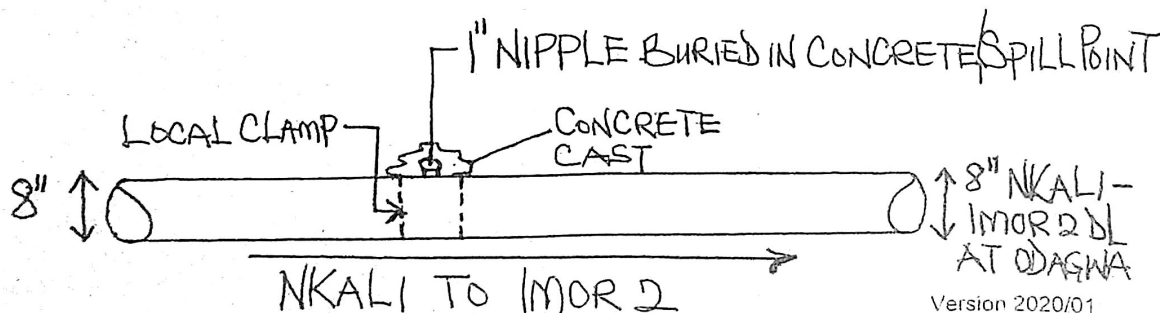
| <input checked="" type="checkbox"/> Crude oil theft (illegal bunkering) point, | <input type="checkbox"/> Saver-pit over flow | <input type="checkbox"/> Third party tampering with Clamp |

- ☒ Third party interference (Sabotage ☐; crude theft ☒; Line theft ☐; Accidental 3rd party damage ☐
☐ Operational ☐ Others (including Mystery spills) _____

E. GRAPHIC DESCRIPTION OF LEAK POINT (while detailed description of the leak point should be contained in the leak report, overview sketch of the site should be added as appendix 1) A SECTION OF 8" NKALI-IMOR 2 DELIVERY LINE AT ODAGWA SHOWING 1" NIPPLE BURIED INSIDE A CONCRETE CAST AT 12 O'CLOCK POSITION BY UNKNOWN PERSON(S).

REPAIR BY CLAMPING/CRUDE OIL RECOVERY
