# JOINT INVESTIGATION REPORT

INCIDENT NO: 2827355 JIV report S/N: 0743

1. Fountain Incident Number: 2827355 2. Type of incident\* OIL SPILL  
3. Name of Location 16" EGBEMA - ASSA PIPELINE  
4. Name of nearest community OBILE 5. State: IMO 6. LGA OHIAJI - EGBEMA  
7. Production Facility/Installation CRUDE OIL PIPELINE  
8. Asset Owner/Hub THE SHELL PETROLEUM DEVELOPMENT COMPANY

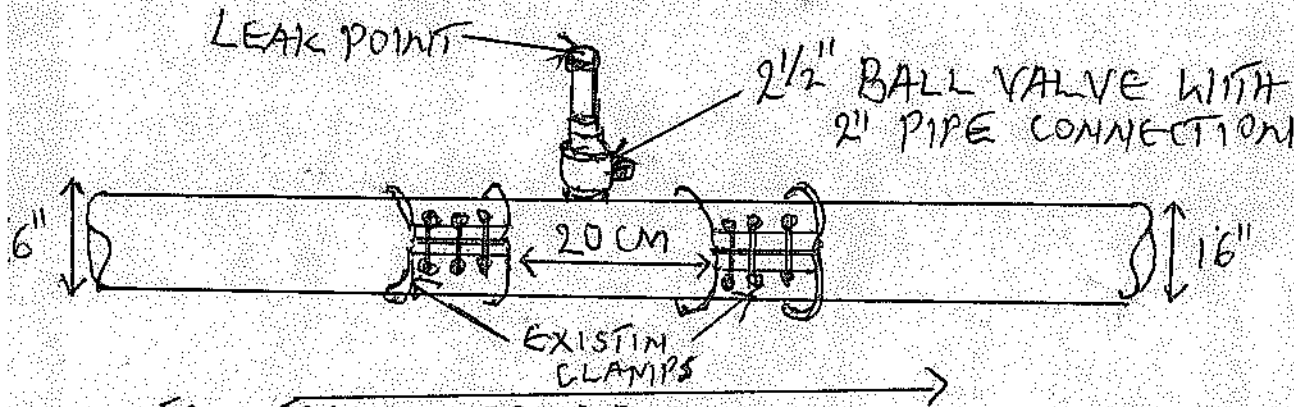
| <input checked="" type="checkbox"/> Failed Weld-on illegal hot tap valve | <input type="checkbox"/> Failed Clamp, | <input type="checkbox"/> Missing Pipeline/Flowline |
| <input checked="" type="checkbox"/> Crude oil theft (illegal bunkering) point, | <input type="checkbox"/> Saver-pit over flow | <input type="checkbox"/> Third party tampering with Clamp |

SECTION OF 16" EGBEMA - ASSA PIPELINE AT OBILE  
SHOWING CRUDE OIL THEFT POINT INSTALLED AT 12 O' CLOCK  
POSITION BY UNKNOWN PERSONS.

REPAIR WORK WAS DONE BY CLAMPING
