JOINT INVESTIGATION REPORT

INCIDENT NO: 2828645 JIV report S/N:

1. Fountain Incident Number: 2828645 2. Type of incident* OIL SPILL
3. Name of Location 18" ASSA - RUMUEKPE PIPELINE
4. Name of nearest community UBUBO OCHI State: IMO 6. LGA OHAJI - EGBEMA
7. Production Facility/Installation CRUDE OIL PIPELINE
8. Asset Owner/Hub THE SHELL PETROLEUM DEVELOPMENT COMPANY
OF NIGERIA LIMITED / PIPELINE

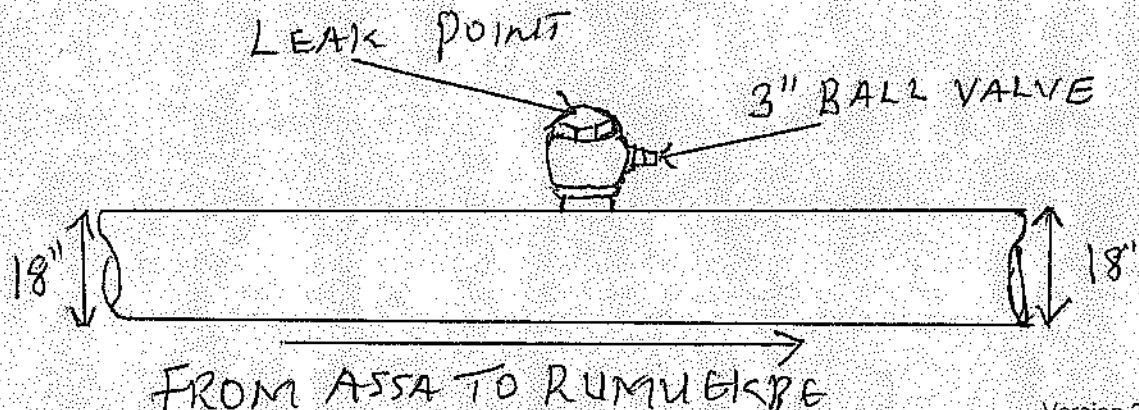
| <input checked="" type="checkbox"/> Failed Weld-on illegal hot tap valve | <input type="checkbox"/> Failed Clamp, | <input type="checkbox"/> Missing Pipeline/Flowline |
| <input checked="" type="checkbox"/> Crude oil theft (illegal bunkering) point, | <input type="checkbox"/> Saver-pit over flow | <input type="checkbox"/> Third party tampering with Clamp |

SECTION OF 18" ASSA - RUMUEKPE PIPELINE AT UBUBO OCHIA SHOWING CRUDE OIL THEFT POINT INSTALLED AT 12 O'CLOCK POSITION BY UNKNOWN PERSONS.

REPAIR BY CLAMPING COMPLETED.
RECOVERY ACTIVITIES ONGOING.
